# Gravel Road Design & Maintenance Plan

*Wildewood Estates*

*Rome, Maine*

*Maine Environmental Solutions, LLC*

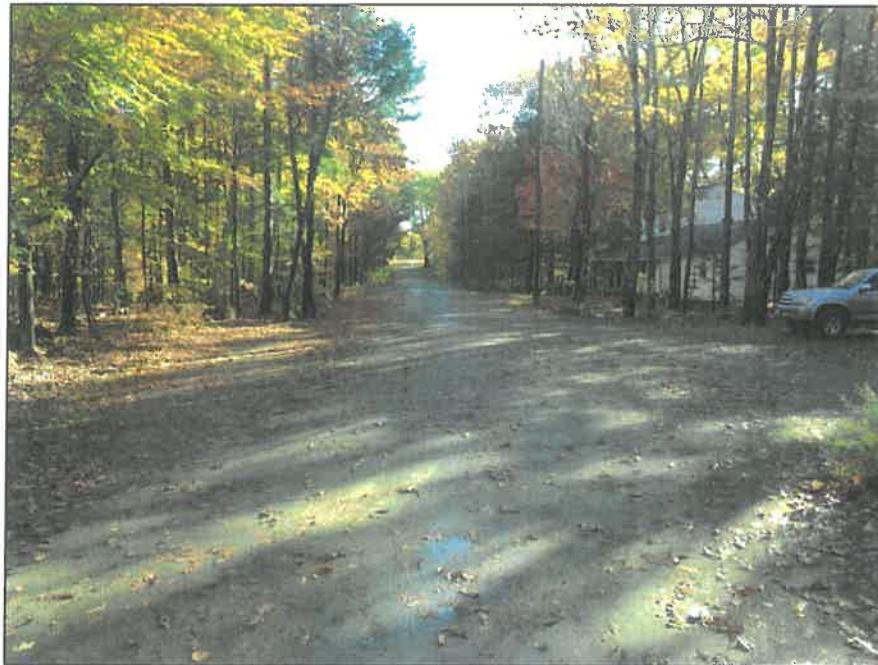
**Site # 1:** Beginning of Wildewood Estates, 558' to end of new bluestone section beyond Pole # 3.

**Issues:** Site has good elevation above surrounding grades, some minor potholes and shoulder berms beginning to form

**Fix:** Cut potholes and maintain crown at  $\frac{1}{2}$ " per foot with regular grading.

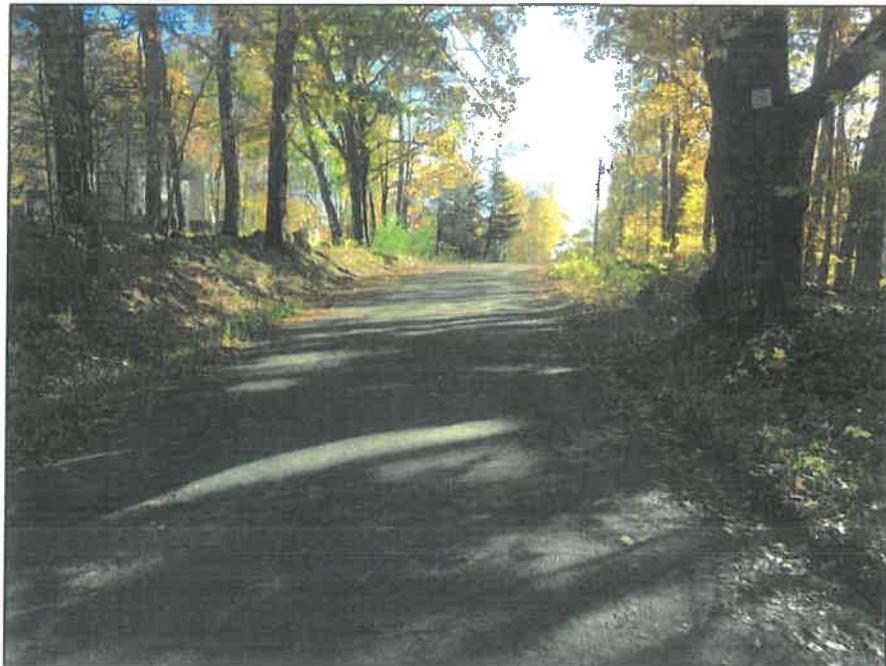
**Site # 2:** End of Site # 1- 176' to Duggan driveway

**Issues:** Lack of sufficient surface crown causing rutting of shoulders. Shoulder berms

**Fix:** Shave shoulder berms and install 6" (pre-compacted depth) 1" minus crushed gravel or bluestone and compact to  $\frac{1}{2}$ " per foot crown.

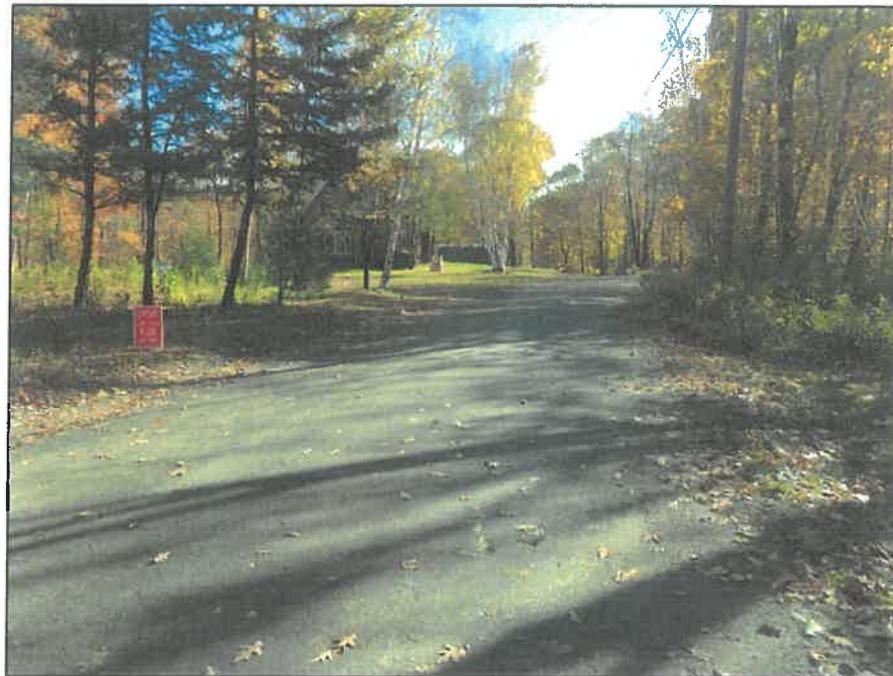
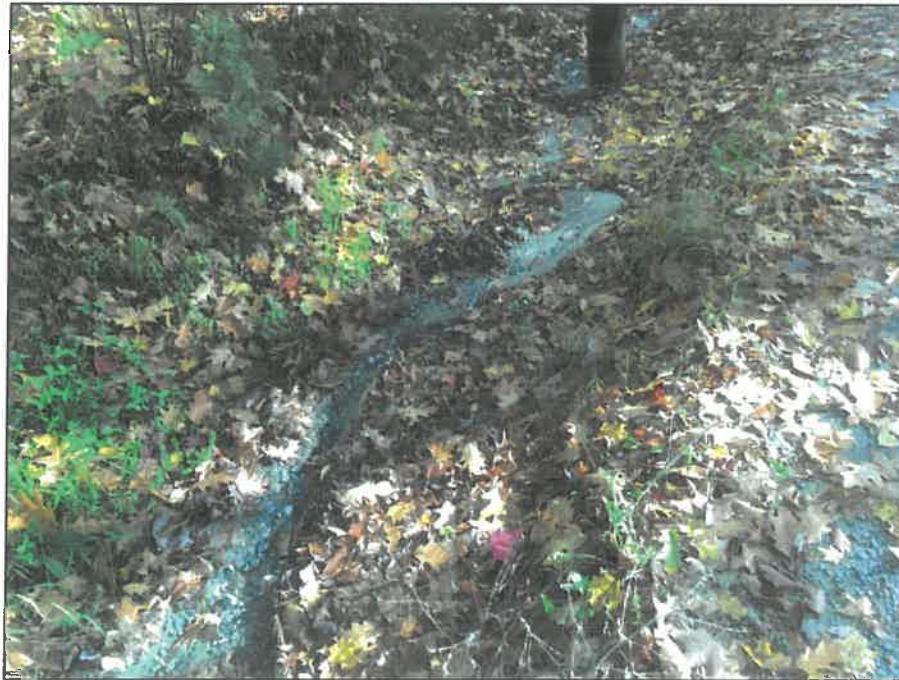
**Site # 3: End of Duggan driveway – 887' to pavement on hill,**

**Issues:** Insufficient surface crown, rutting, lack of ditching on left side to driveway culvert, ledge present. Left side ditch full of existing surface material (bluestone)

**Fix:** Define ditching on left to driveway culvert to greatest extent possible. Install 8" (pre-compacted depth) 1" minus crushed gravel or bluestone and compact to  $\frac{1}{2}$ " per foot crown.

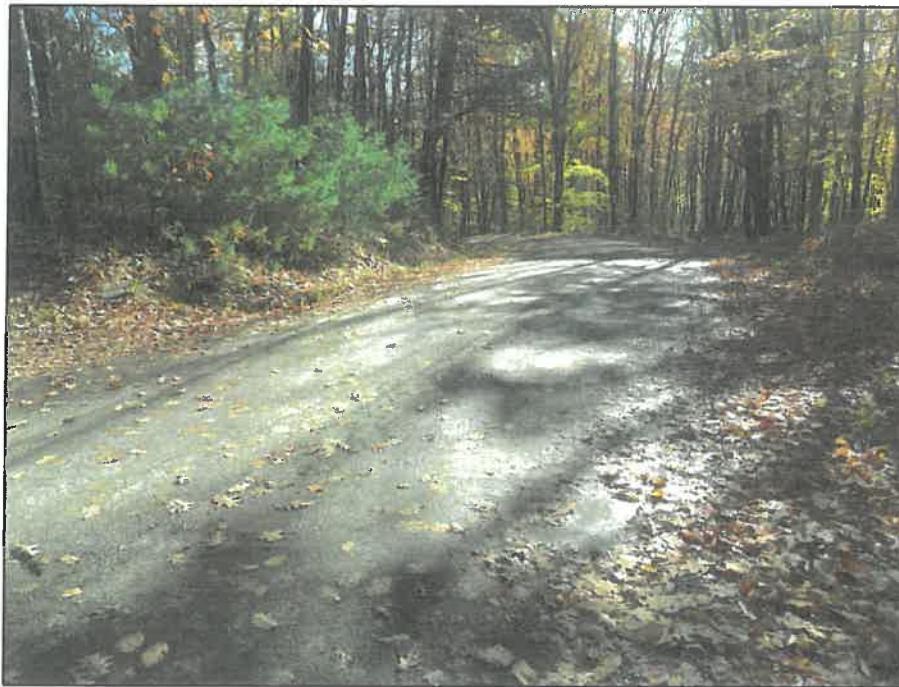
**Site # 4: Paved section of road**

**Issues:** Pavement cracking but drainage is good

**Fix:** None needed

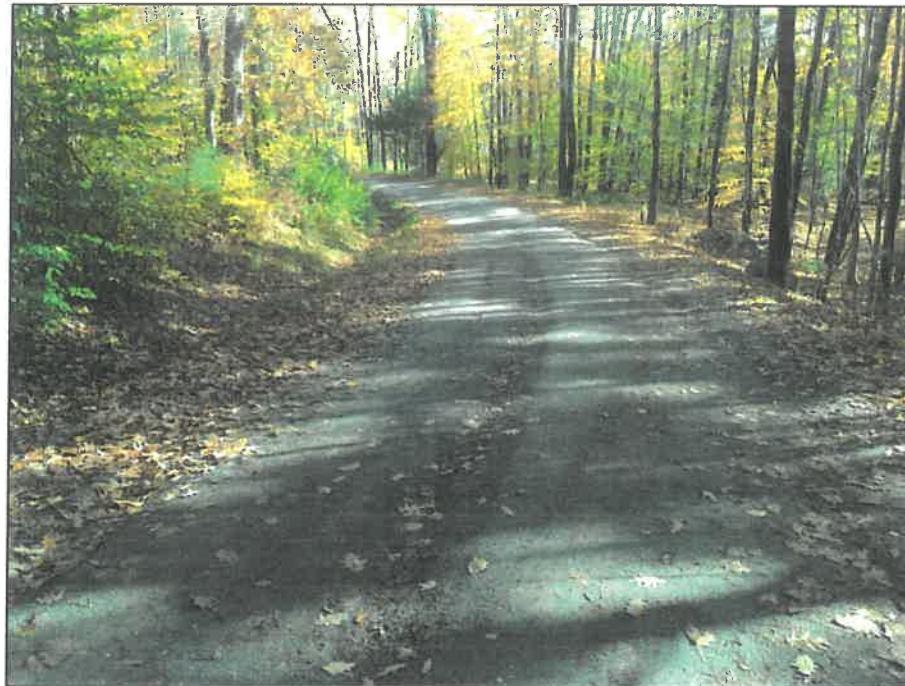
**Site # 5: End of pavement – 247' to Cedar Estates**

**Issue:** Lack of sufficient surface material to shed water off driving surface, shoulder berms

**Fix:** Install 6" (pre-compacted depth) 1" minus crushed gravel or bluestone and compact to  $\frac{1}{2}$ " per foot crown.

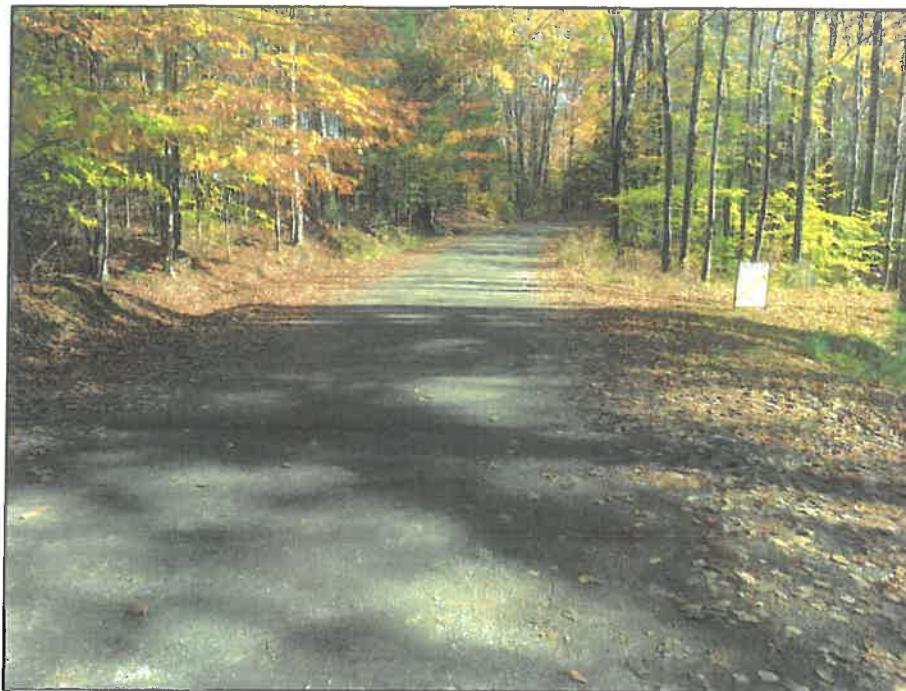
**Site # 6: Beyond Pole # 13 – Cedar Estates – 400' to Pole # 14.5**

**Issues:** Shoulder berms inhibiting drainage off surface, lack of surface crown

**Fix:** Shave shoulder berms and install 6" (pre-compact depth) 1" minus crushed gravel or bluestone and compact to  $\frac{1}{2}$ " per foot crown.

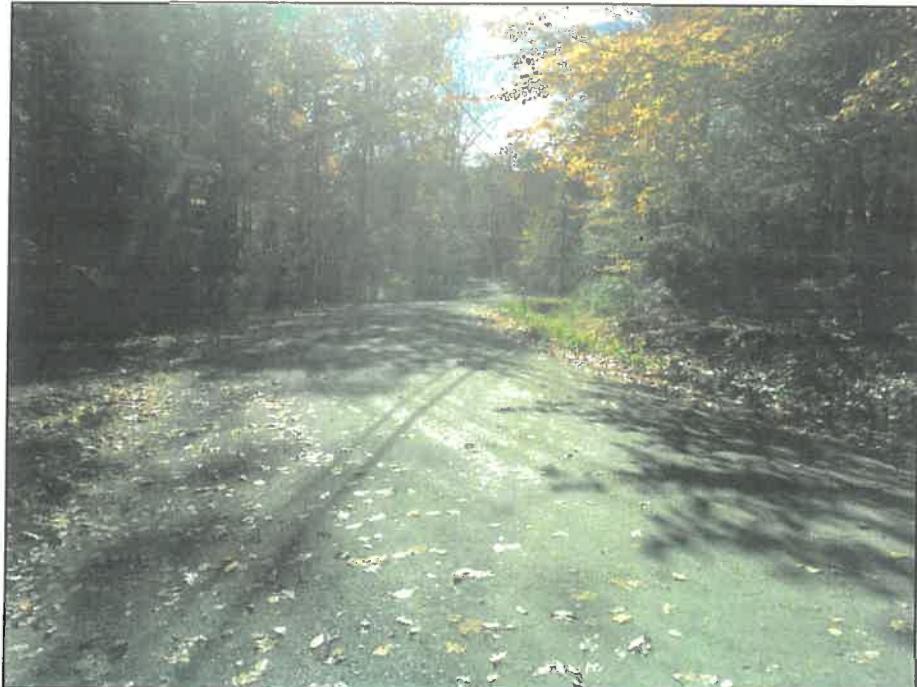
**Site #7: Curve at Pole # 14.5 down - hill – 1467' to Pole # 19**

**Issues:** New bluestone rutting on hill shoulders

**Fix:** Using existing surface material, grade to shape  $\frac{1}{2}$ " per foot crown. Add surface material as needed.

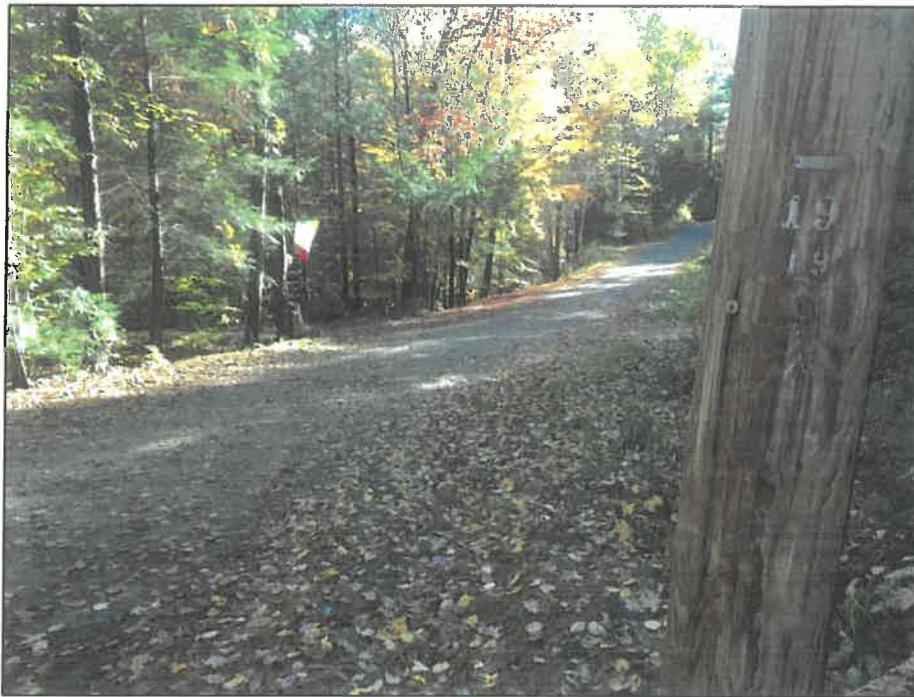
**Site # 8: Pole # 19 (Intersection on Balsam) 492' to Driveway # 171**

**Issues:** Lack of sufficient surface material to shed water off driving surface.

**Fix:** Install 6" (pre-compacted depth) 1" minus crushed gravel or bluestone and compact to  $\frac{1}{2}$ " per foot crown.

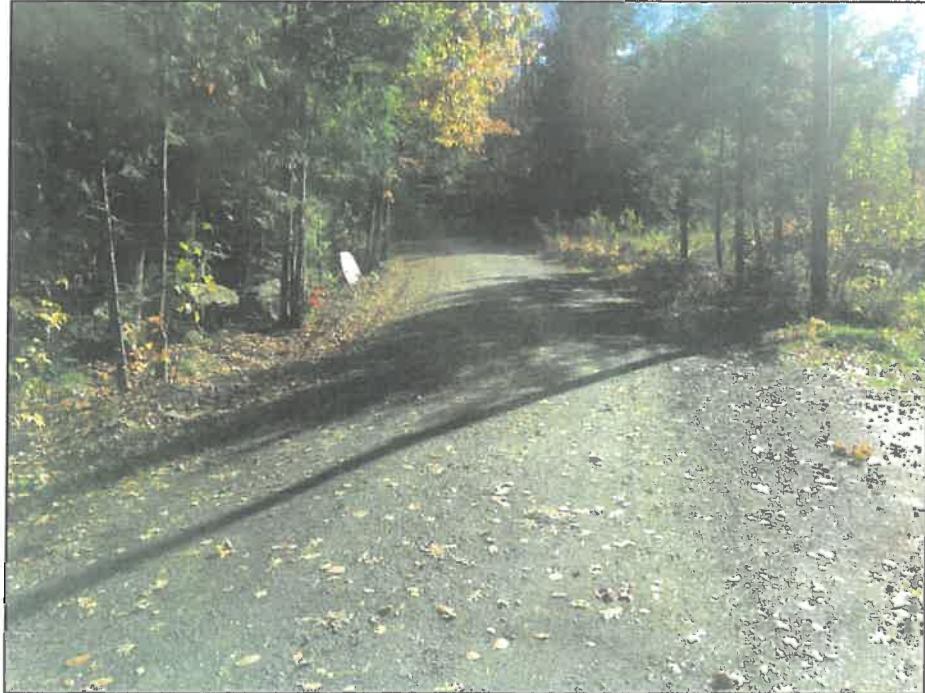
**Site # 9: Driveway # 171 – 900' to Byrne driveway (#204)**

**Issues:** Middle to end sections lack crown.

**Fix:** Maintain crown in beginning section and add 6" (pre-compacted depth) 1" minus crushed gravel or bluestone and compact to  $\frac{1}{2}$ " per foot crown on remainder

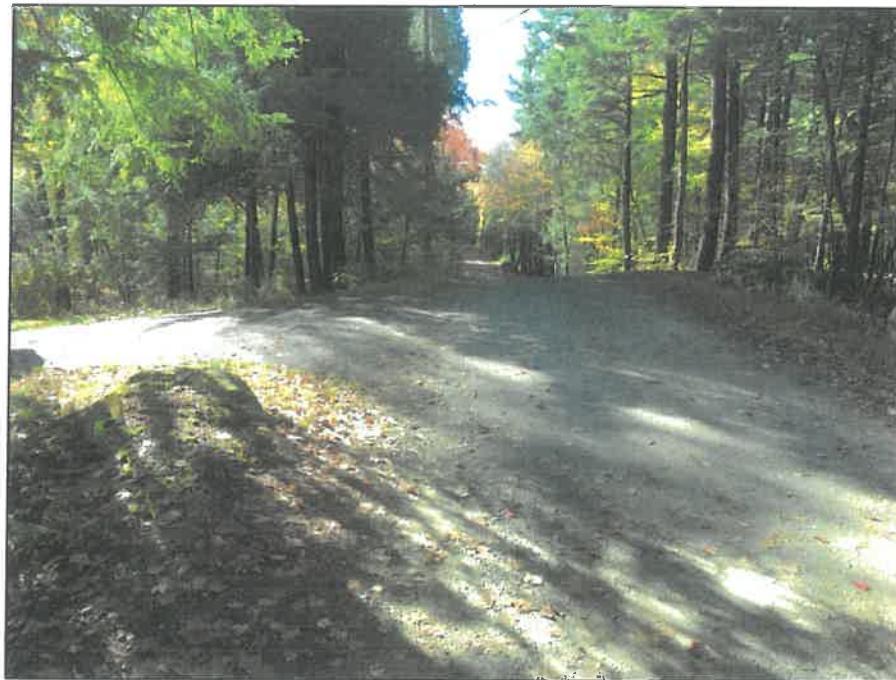
**Site # 10: Driveway # 204 – 440' to Driveway # 225 (Cardinali)**

**Issues:** Surface is flat and lacks sufficient surface crown

**Fix:** Add 6" (pre-compactated depth) 1" minus crushed gravel or bluestone and compact to  $\frac{1}{2}$ " per foot crown on remainder

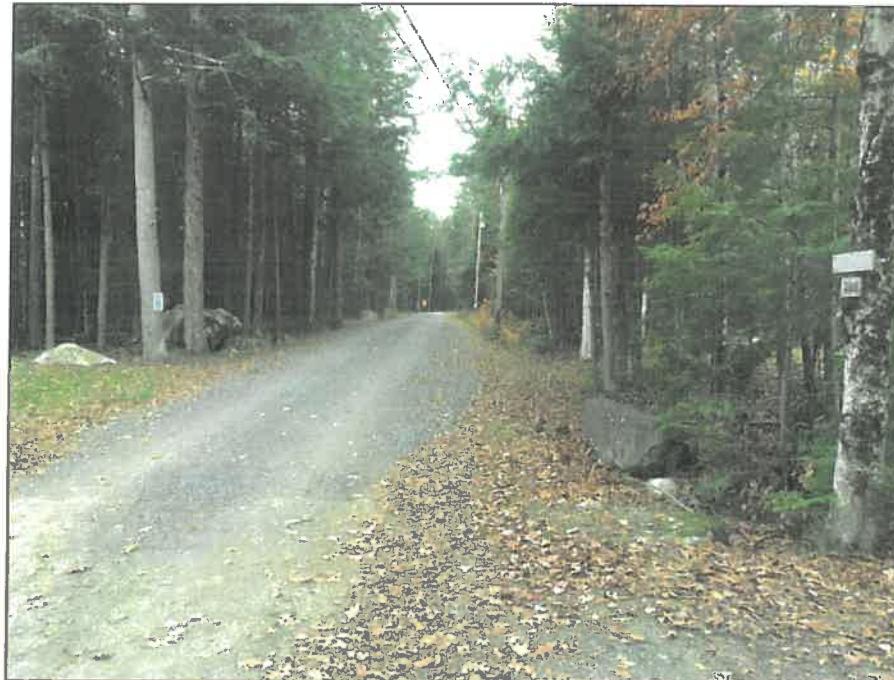
**Site # 11: Driveway # 225 – 991' to Driveway # 90**

**Issues:** New bluestone in this section with older bluestone material on hill

**Fix:** Maintain crown at  $\frac{1}{2}$ " per foot with regular grading.

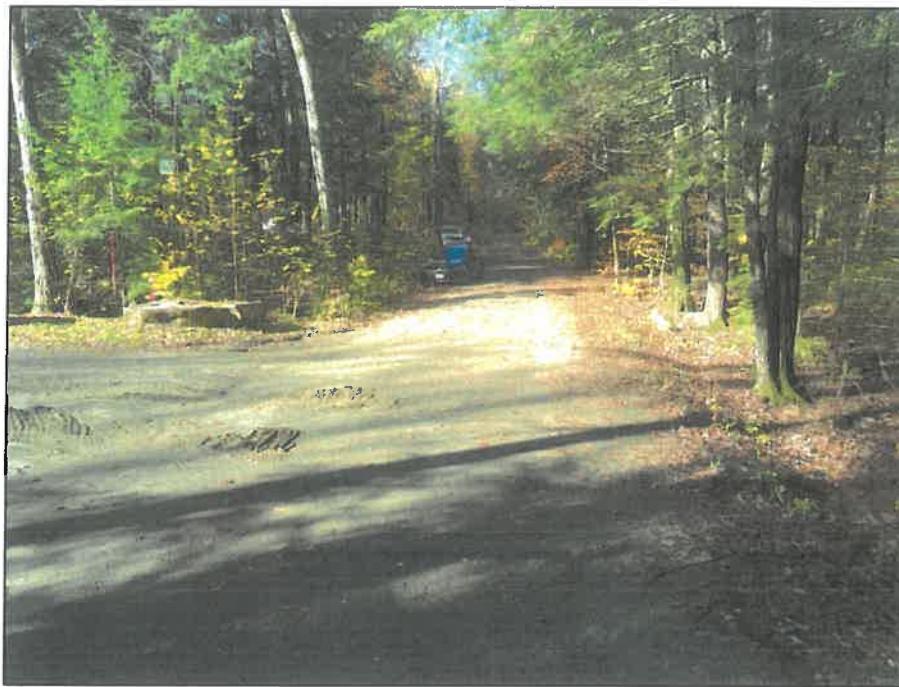
**Site # 12: Driveway # 90 – 1123' to Pole # 8**

**Issues:** Surface is flat and lacks sufficient surface crown, some potholes forming, ledge is present

**Fix:** Add 4" (pre-compactated depth) 1" minus crushed gravel or bluestone and compact to  $\frac{1}{2}$ " per foot crown on remainder

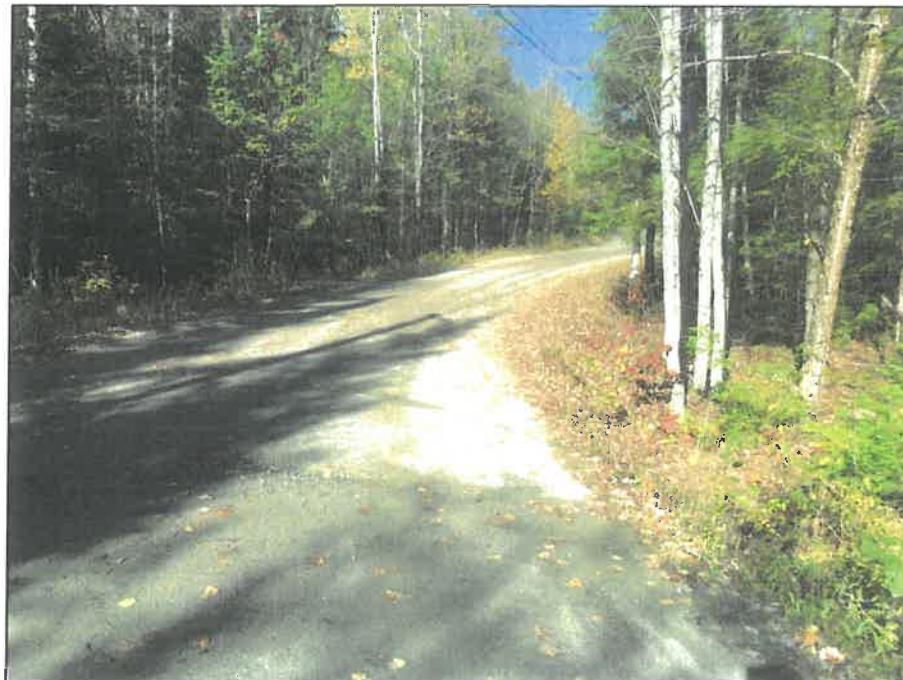
**Site # 13: Pole # 8 – 482' to Spruce/Aspen intersection.**

**Issues:** Shoulder berms present preventing water from getting off road surface and shoulders causing potholes. Surface material needs shaping.

**Fix:** Shave shoulder berms, cut potholes and reshape crown so water drains off surface and shoulders.

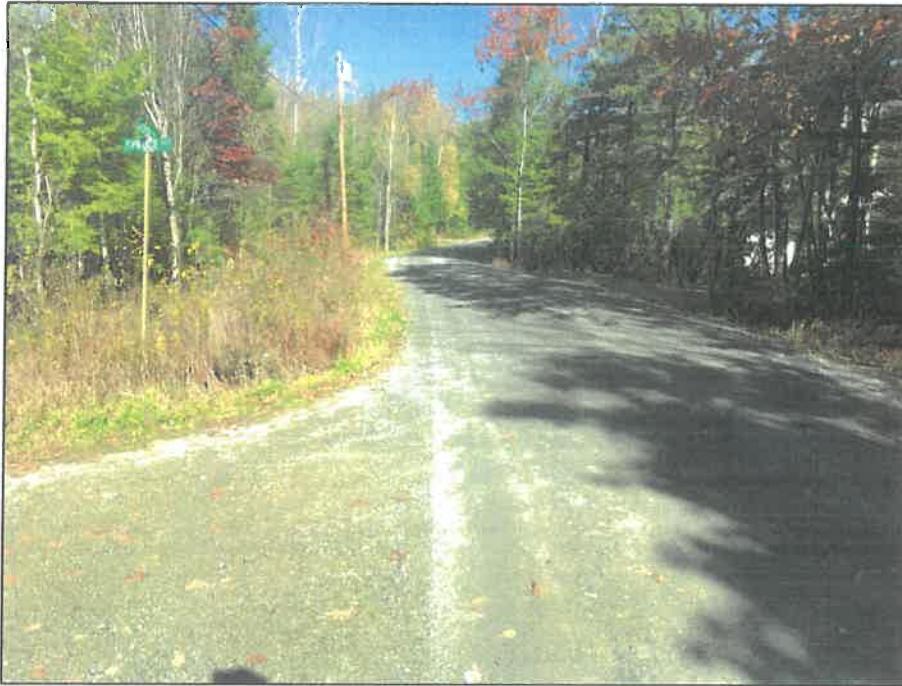
**Site # 14:** Beginning of Aspen – 555' to intersection with Wildewood

**Issues:** Site is in good condition with sufficient bluestone and crown

**Fix:** Maintain crown at  $\frac{1}{2}$ " per foot with regular grading.

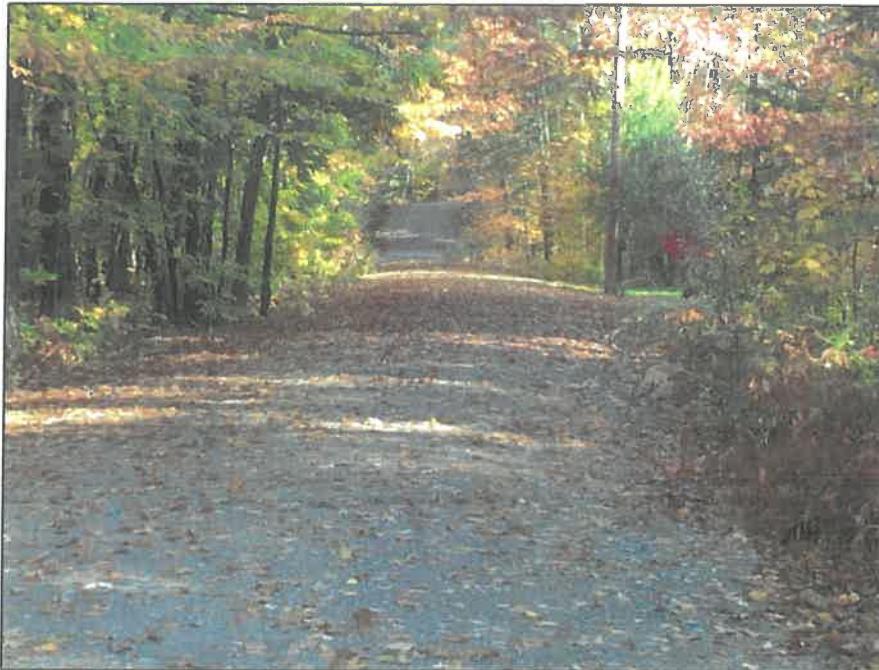
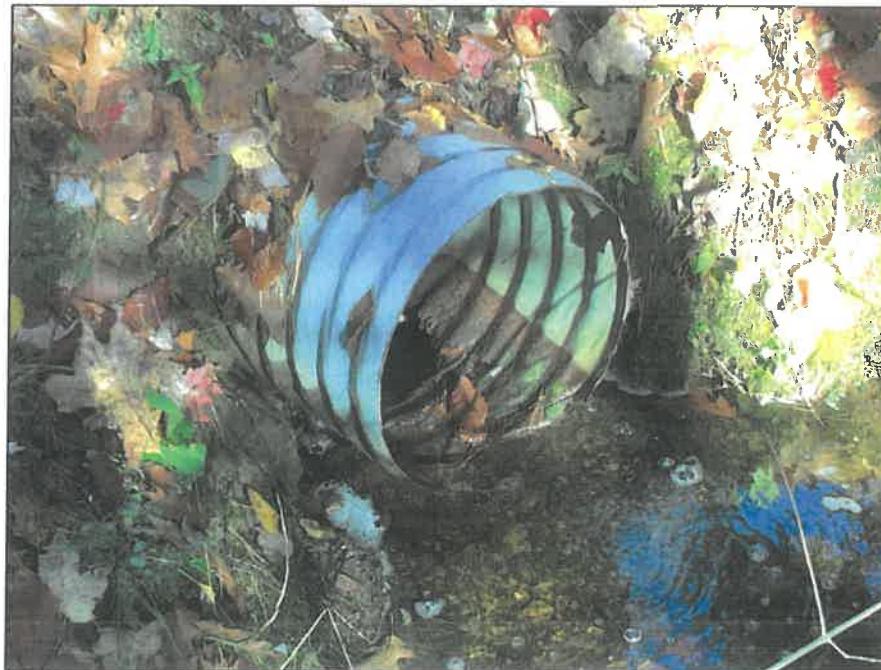
**Site # 1:** Beginning of Birch -629' to end of new gravel section

**Issues:** Site is in good condition with sufficient 1" minus gravel and crown. Existing 18" metal culvert at 424' has failed.

**Fix:** Replace existing culvert with 18" HDPE culvert and maintain crown at  $\frac{1}{2}$ " per foot with regular grading.

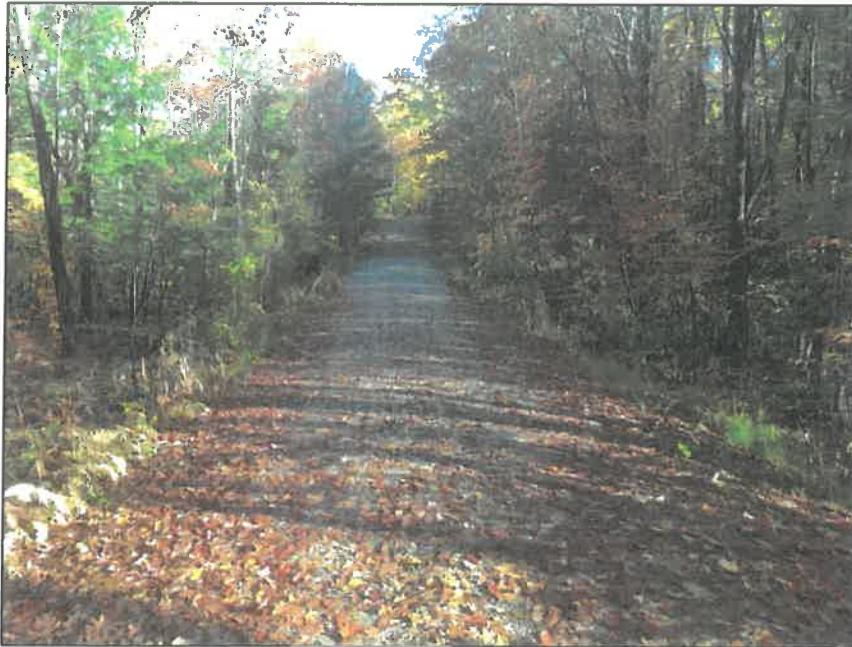
**Site # 2:** Bottom of hill – end of Site # 1 – 900' to Pole # 3.1 at end of road.

**Issues:** Lack of surface crown, rutting, shoulder berms

**Fix:** On hill - Add 12" (pre-compacted depth) 1" minus crushed gravel or bluestone and compact to  $\frac{1}{2}$ " per foot crown. Install 6" (pre-compacted depth) 1" minus crushed gravel or bluestone and compact to  $\frac{1}{2}$ " per foot crown on remainder of road

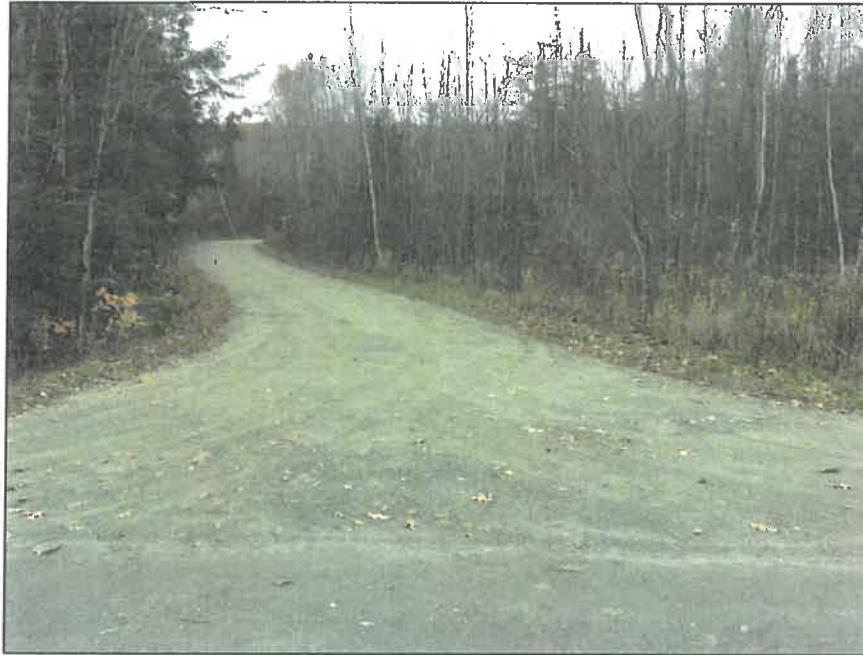
## Spruce Estates

**Issues:** Lack of surface crown, rutting, on hills, shoulder berms

**Fix:** Shave shoulder berms and install 6" (pre-compacted depth) 1" minus crushed gravel or bluestone and compact to  $\frac{1}{2}$ " per foot crown.

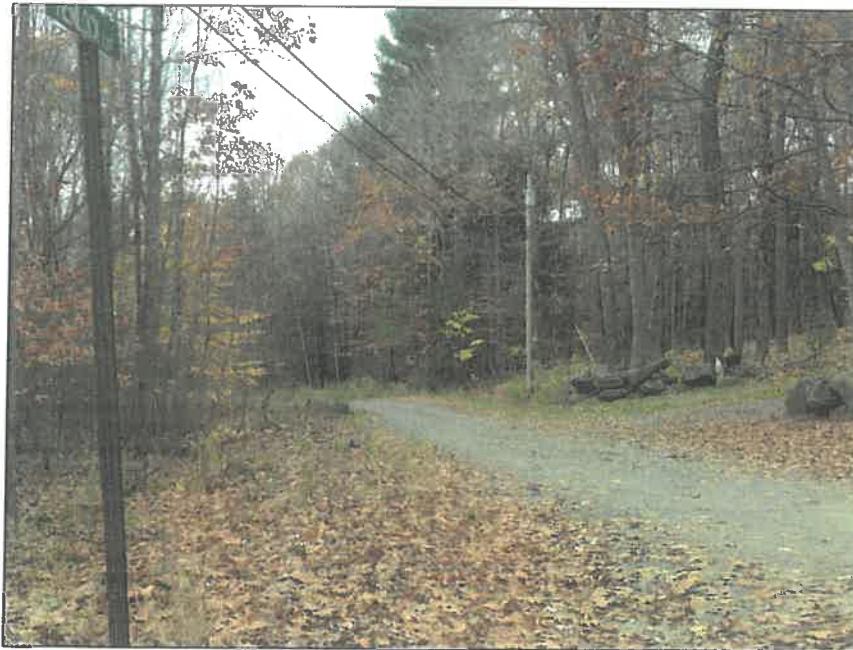
## Hemlock Estates

**Issues:** Lack of surface crown, rutting, significant shoulder berms

**Fix:** Shave /remove shoulder berms and install 6" (pre-compacted depth) 1" minus crushed gravel or bluestone and compact to  $\frac{1}{2}$ " per foot crown.

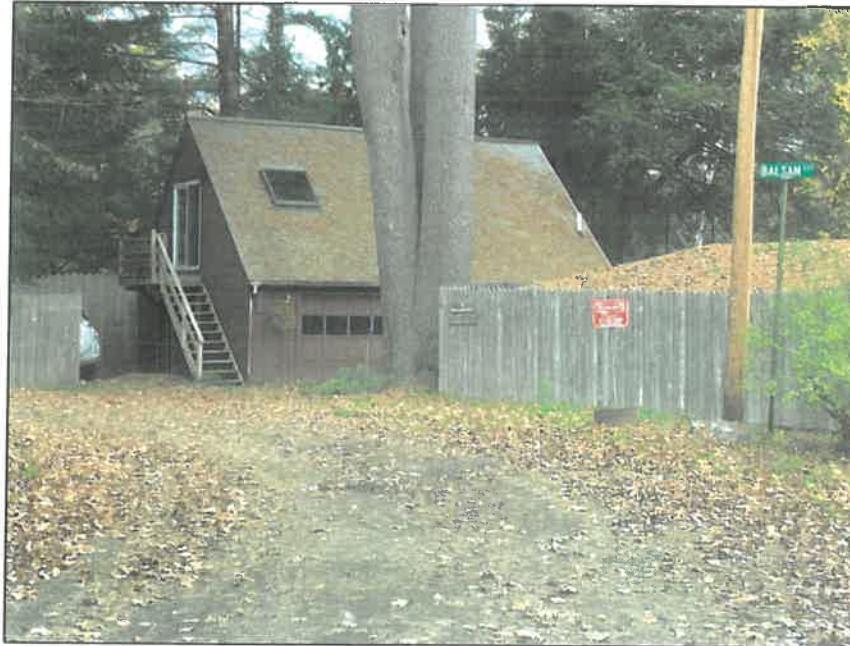
## Balsam Estates

**Issues:** Lack of surface crown in beginning. Remainder of road has had recent work done and is in good condition with new culverts and crown.

**Fix:** Install 6" (pre-compacted depth) 1" minus crushed gravel or bluestone and compact to  $\frac{1}{2}$ " per foot crown along beginning section. Maintain remainder with  $\frac{1}{2}$  per foot crown.

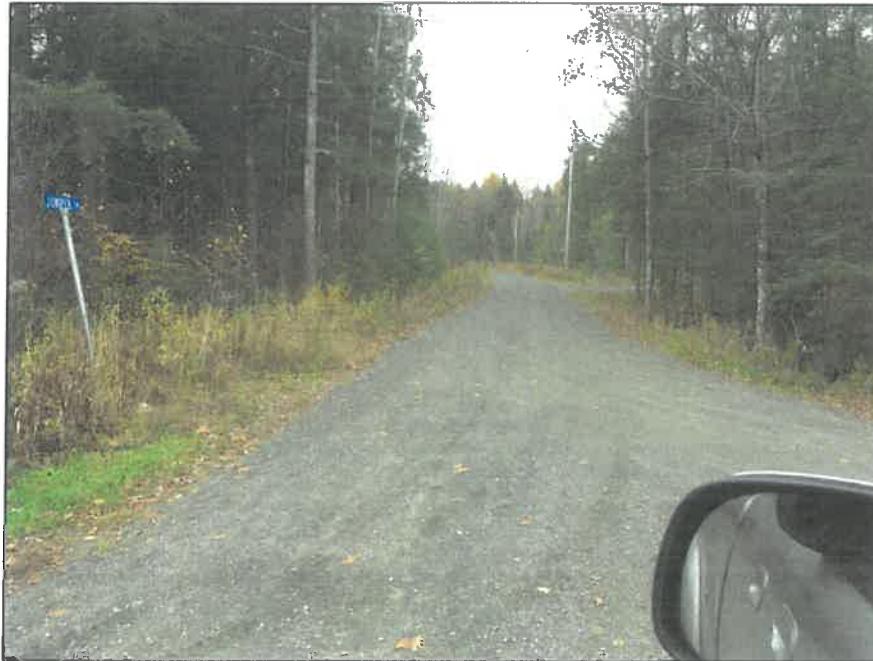
## Juniper Estates

**Issues:** Beginning of south side of Juniper – new bluestone added, Remaining .1 mile – lack of surface crown

**Fix:** Maintain crown on new section. Install 3-4" (pre-compact depth) 1" minus crushed gravel or bluestone and compact to  $\frac{1}{2}$ " per foot crown on remaining portion of road.

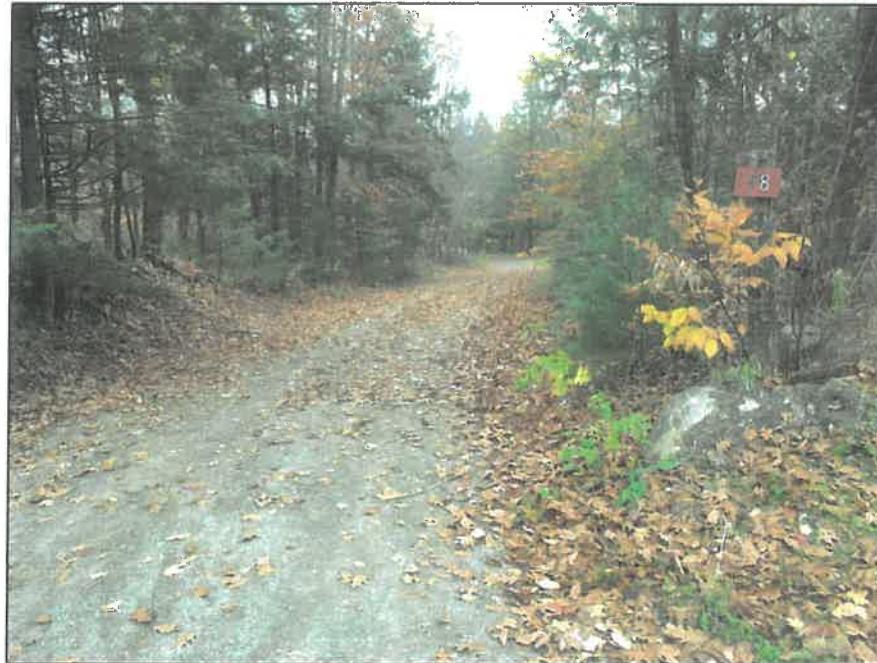
## Hill at Driveway # 98

**Issues:** Road is sloped to existing ditch on left (super-elevated)

**Fix:** Maintain super-elevation to left adding material as needed.

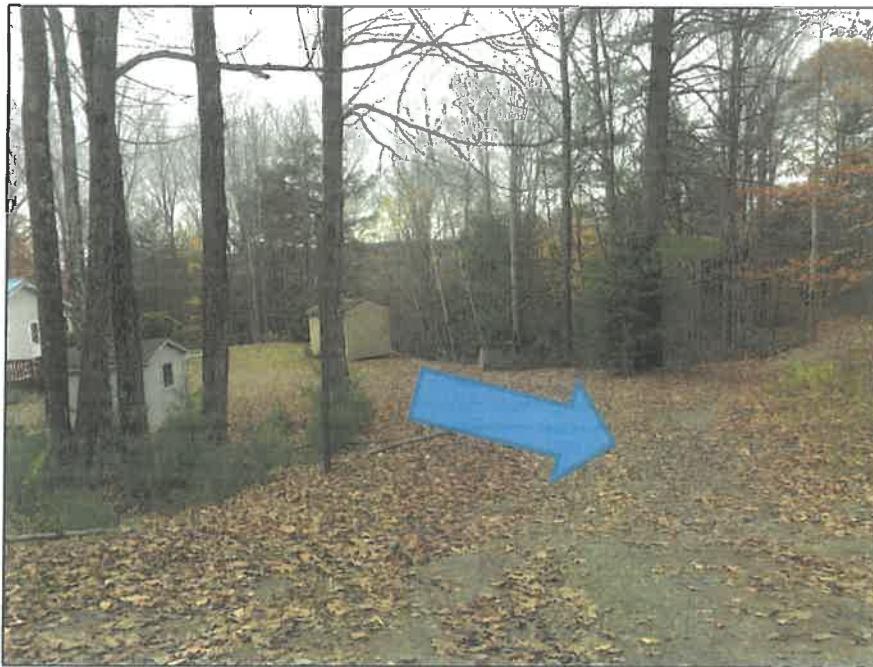
## Cedar Estates

**Issues:** Road is acting as the ditch and water not getting off surface

**Fix:** Super-elevate road to right side, for 75', so water can shed away from driving surface. Raise road base 1' with 4" minus gravel and add 6" (pre-compacted depth) of 1" minus crushed gravel or bluestone to the surface.

If runoff goes down driveway on right, install gravel water bar to move water off road surface.

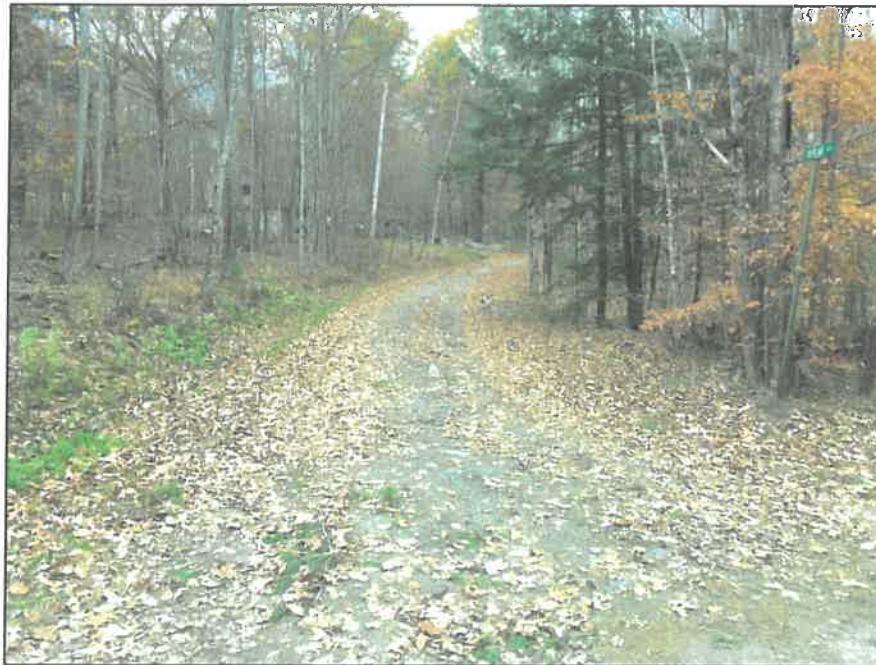
## Poplar Estates

**Issues:** Lack of surface crown, water not reaching ditching, shoulder berms

**Fix:** If construction of a new house on the lot at the end is planned, wait until large vehicles are finished to improve road.

Shave shoulder berms and install 8" (pre-compacted depth) of 1" minus crushed gravel or bluestone and compact to  $\frac{1}{2}$ " per foot crown on sections that have existing ditching. Areas without ditching on left should be super-elevated toward woods on right.
