Gravel Road Design & Management Plan

*Wildewood Estates Road District Rome,
Maine*

Maine Environmental Solutions, LLC

Updated July 2024

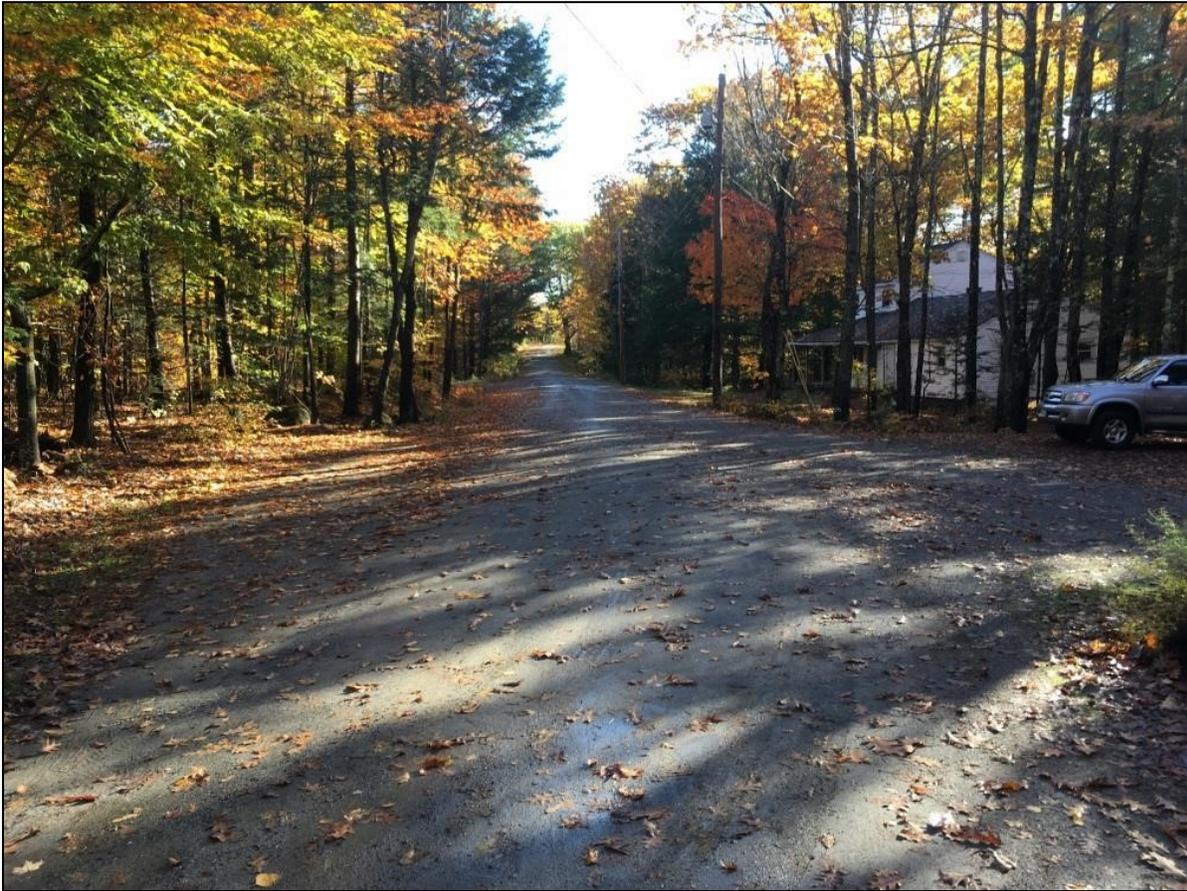
Site # 1: Beginning of Wildewood Estates, 558' to end of new bluestone section beyond Pole # 3.

Issues: Site has good elevation above surrounding grades, some minor potholes and shoulder berms beginning to form

More bluestone has been added to this site but potholes persist. Having potholes cut and the road shaped with a large grader will remove existing potholes.

Fix: Cut potholes and maintain crown at ½" per foot with regular grading.

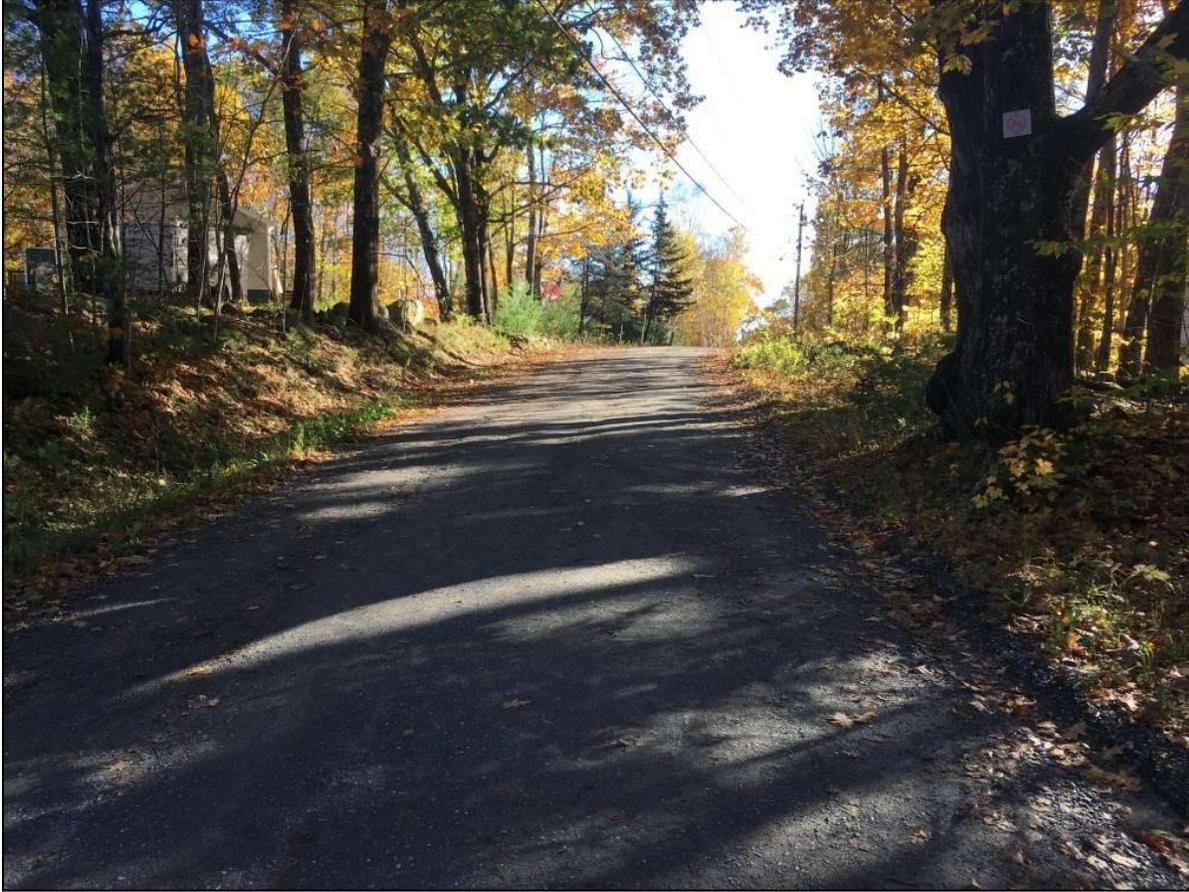
Site # 2: End of Site # 1- 176' to Duggan driveway

Issues: Lack of sufficient surface crown causing rutting of shoulders. Shoulder berms

Shoulder berms have been removed. More bluestone has been added to this site but potholes persist. Having potholes cut and the road shaped with a large grader will remove existing potholes.

Fix: Shave shoulder berms and install 6" (pre-compacted depth) 1" minus crushed gravel or bluestone and compact to 1/2" per foot crown.

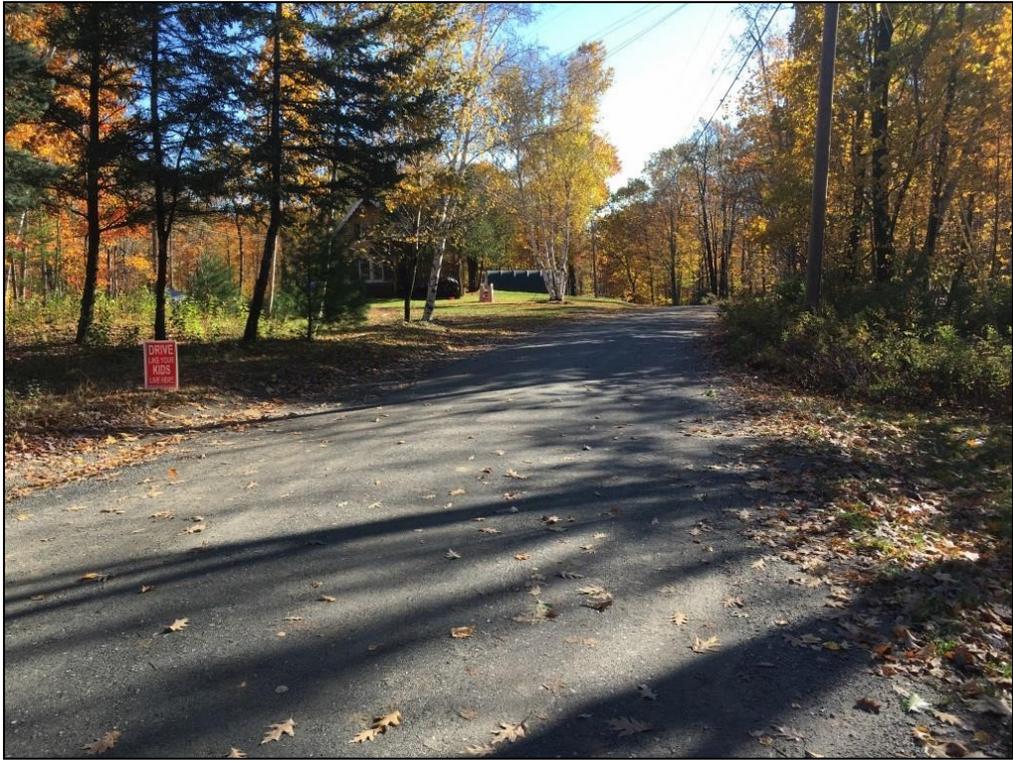
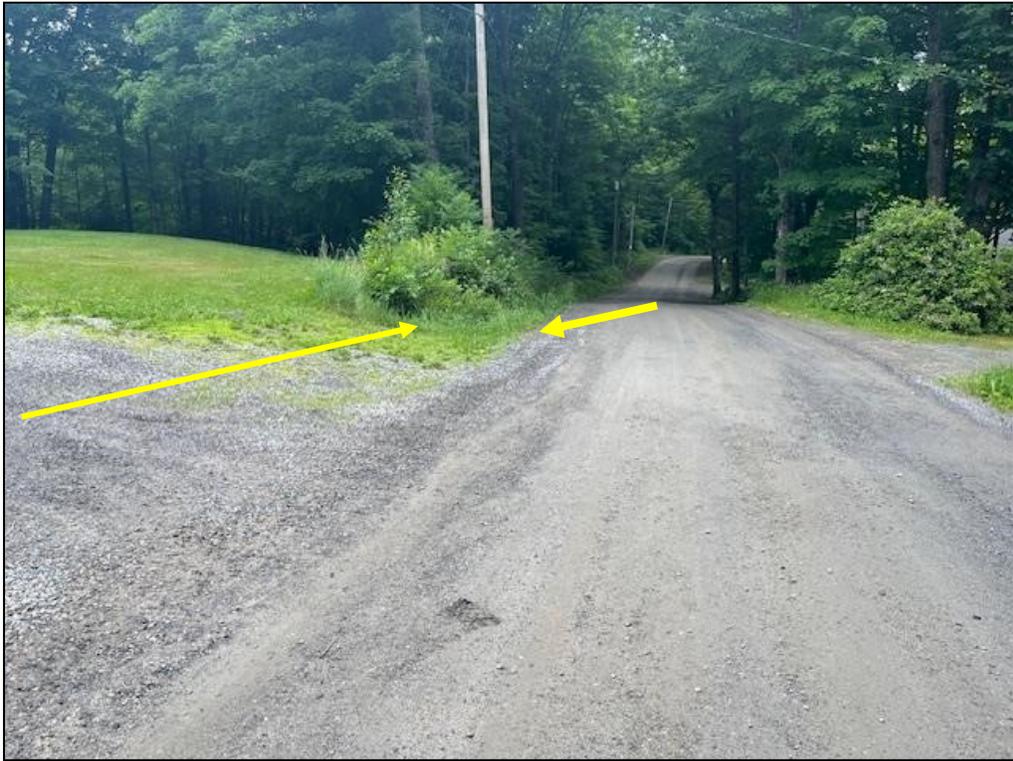
Site # 3: End of Duggan driveway *on right* – 887' to pavement on hill,

Issues: Insufficient surface crown, rutting, lack of ditching on left side to driveway culvert, ledge present. Left side ditch full of existing surface material (bluestone)

More ditching has been installed and bluestone added to increase crown. At end of Depetriotano driveway, increase crown with bluestone gravel so water reaches existing ditching and gets off shoulder. A water bar across Depetriotano driveway and shaping the shoulder, directing water to

Fix: Define ditching on left to driveway culvert to greatest extent possible. Install 8" (pre-compacted depth) 1" minus crushed gravel or bluestone and compact to ½" per foot crown.

existing ditching on north side of Wildewood would help limit stormwater entering Wildewood from

the driveway. Add more bluestone to increase crown by Pole # 10.5. Priority #:

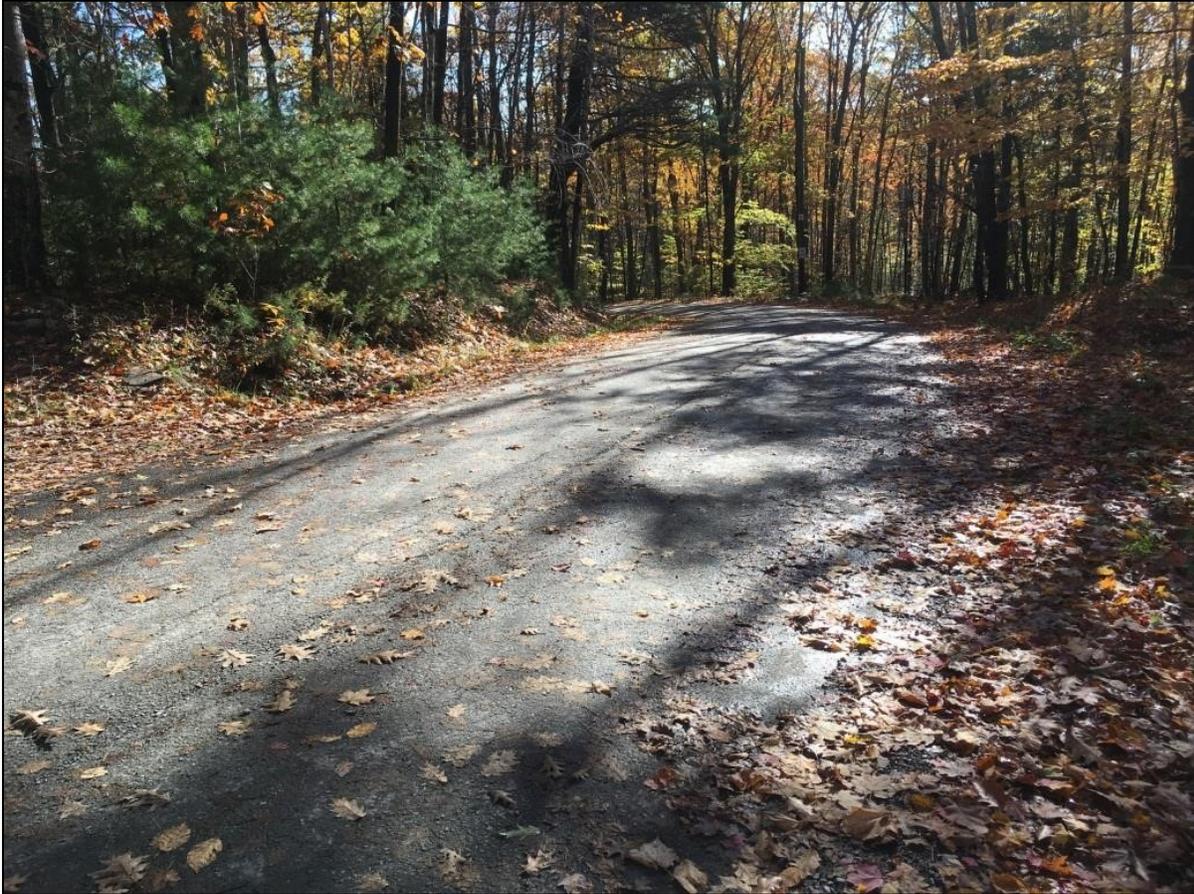
Site # 4: Paved section of road

Issues: Pavement cracking but drainage is good

Fix: *When pavement fails completely and needs to be addressed, have it ground (reclaimed), crowned and rolled with a vibratory compactor. The new surface can be graded and shaped annually along with the rest of the road.*

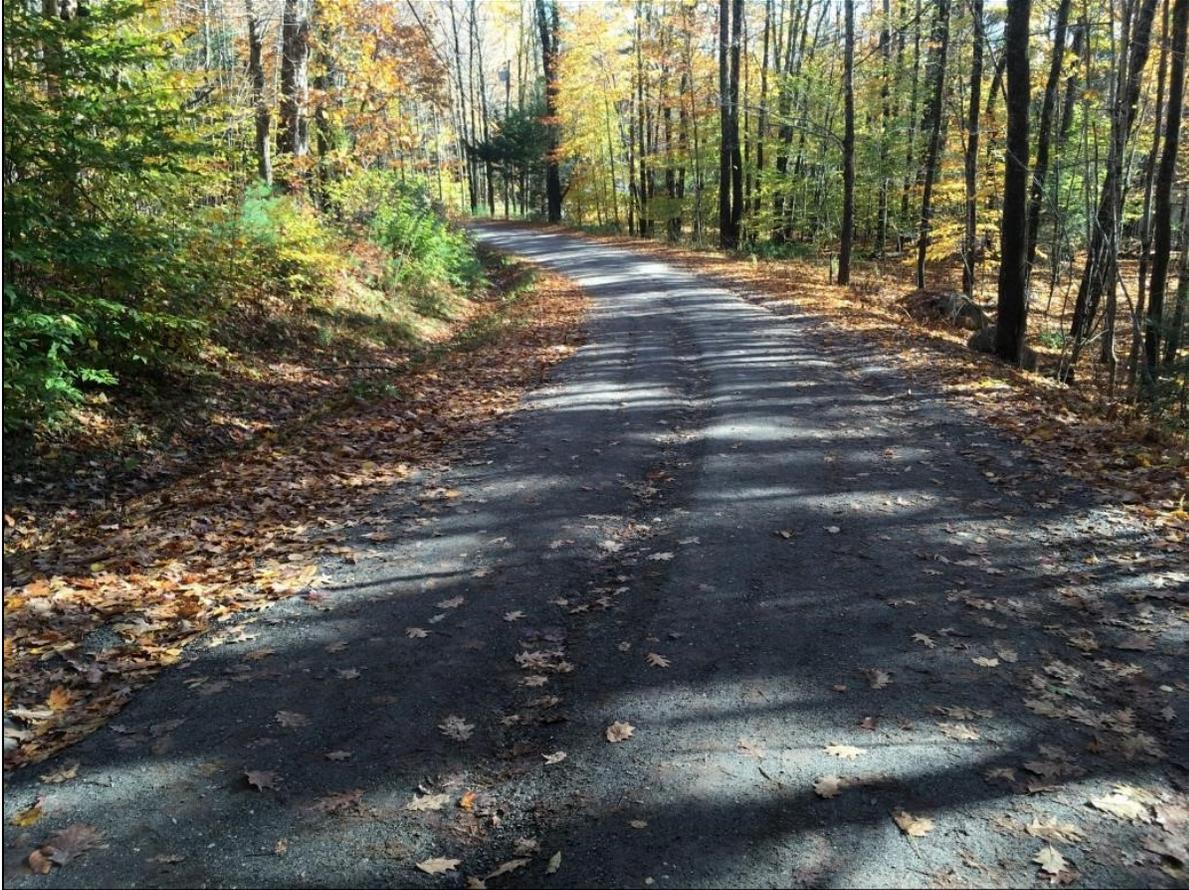
Site # 5: End of pavement – 247' to Cedar Estates

Issue: Lack of sufficient surface material to shed water off driving surface, shoulder berms

*Shoulder berms have been removed and bluestone has been added to this site. **Priority***

Fix: Install 6" (pre-compacted depth) 1" minus crushed gravel or bluestone and compact to ½" per foot crown.

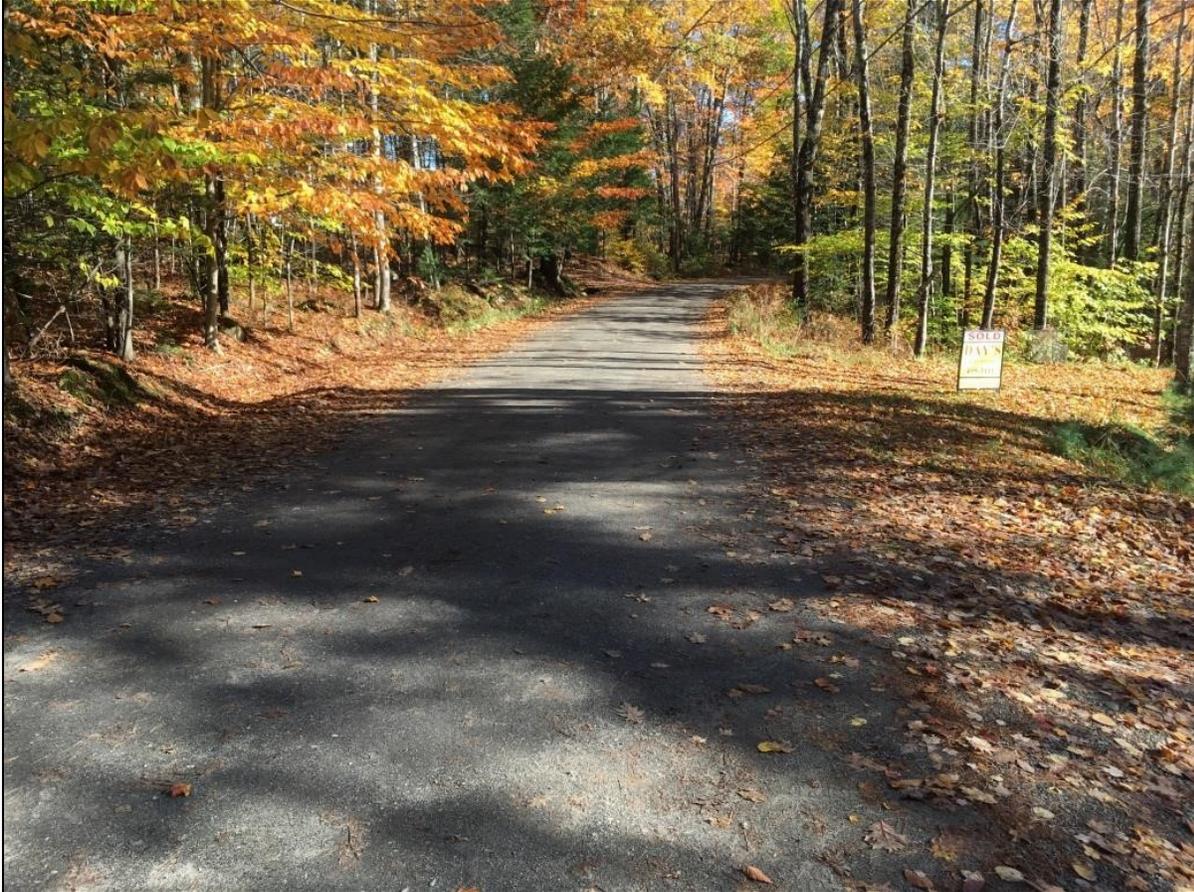
Site # 6: Beyond Pole # 13 – Cedar Estates – 400’ to Pole # 14.5

Issues: Shoulder berms inhibiting drainage off surface, lack of surface crown

Chronic wet area at Pole #13 has been excavated. Fabric and a rock sandwich have been installed. Shoulder berms have been removed and bluestone surface gravel added to increase crown.

Fix: Shave shoulder berms and install 6” (pre-compacted depth) 1” minus crushed gravel or bluestone and compact to ½” per foot crown.

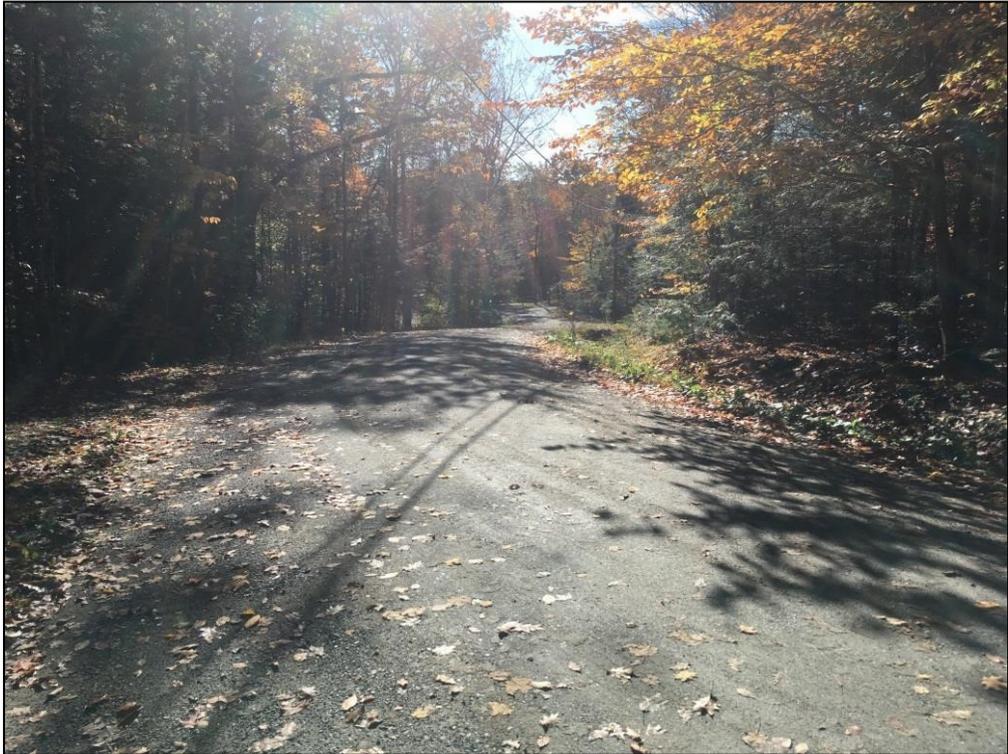
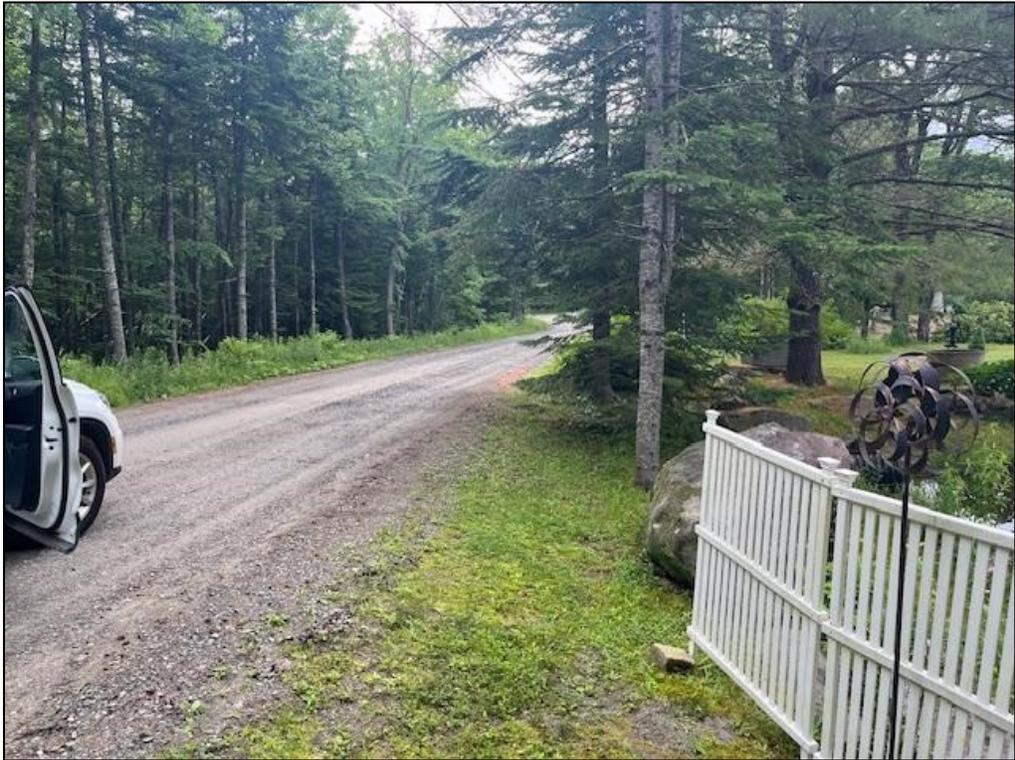
Site #7: Curve at Pole # 14.5 down -hill – 1467' to Pole # 19

Issues: Rutting on hill shoulders

Previously suggested work has been completed. Site was severely impacted by storm in December of 2023. Intersection with Aspen became saturated, and road washed out near Kish pond. 6" stone was added to soft area at intersection and surface gravel installed over the top. Area beyond Kish pond had to be rebuilt with base gravel. Continue to add smaller stone to saturated/soft areas as needed. Stone should be 1.5" or larger to augment existing base materials and increase drainage.

Fix: Using existing surface material, grade to shape $\frac{1}{2}$ " per foot crown. Add surface material as needed.

Surface gravel or bluestone can be added over stone and crowned to $\frac{1}{2}$ " per foot. A second culvert is planned for outlet of Kish pond.

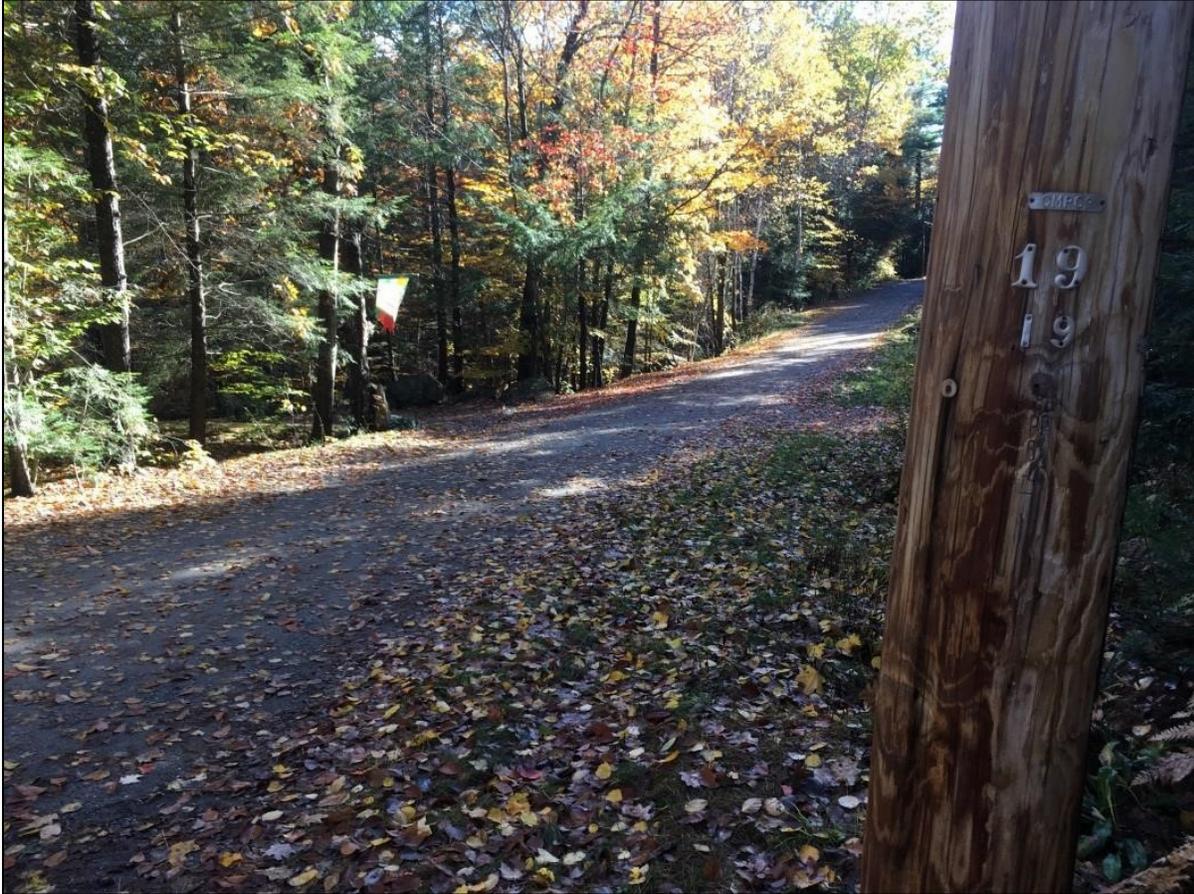
Site # 8: Pole # 19 (Intersection on Balsam) 492' to Driveway # 171

Issues: Lack of sufficient surface material to shed water off driving surface, *potholes*

Not completed, needs surface material and crowning.

Fix: Install 6" (pre-compacted depth) 1" minus crushed gravel or bluestone and compact to 1/2" per foot crown.

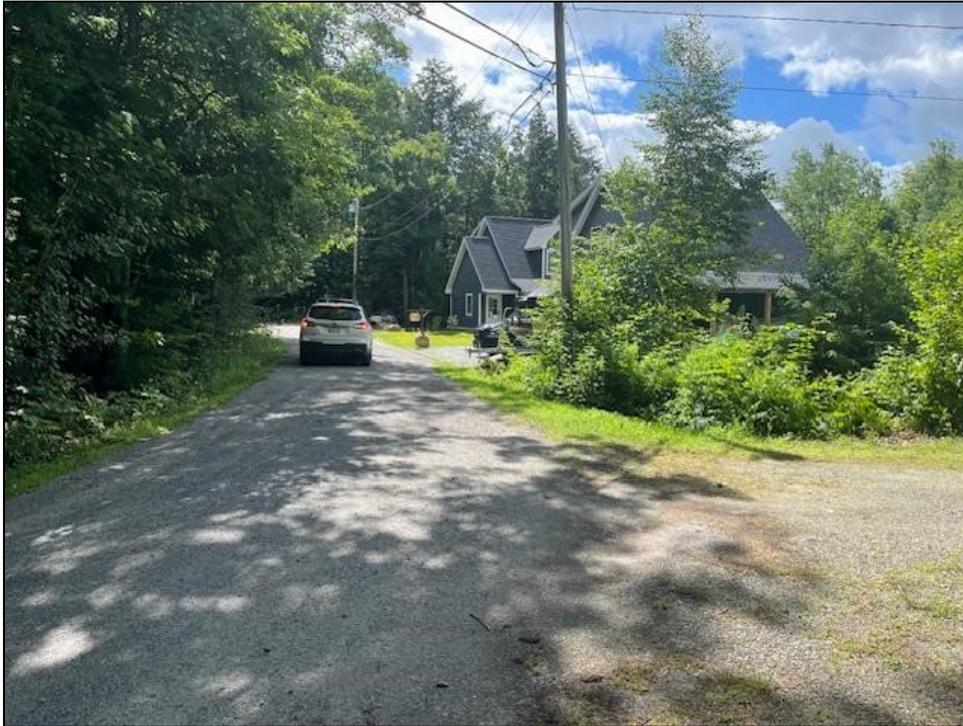
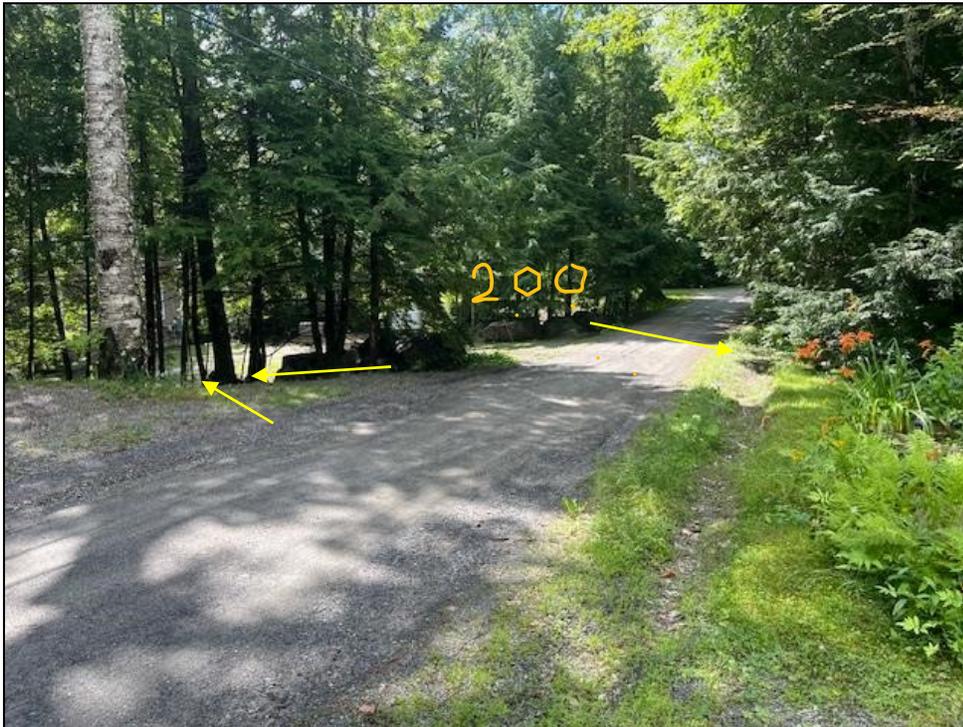
Site # 9: Driveway # 171 – 900’ to Byrne driveway (#204) **Issues:**

2024 photo in same location with new house, #177, on right.

Middle to end sections lack crown.

Not completed, needs surface material and crowning. At driveway #200, cut shoulder on east side before driveway. Plans in place to excavate and rebuild last 100' of site with fabric, base and surface gravel. Surface will be super-elevated, so water drains to west. Deepen/extend ditching for last 100' on west side.

Fix: Maintain crown in beginning section and add 6" (pre-compacted depth) 1" minus crushed gravel or bluestone and compact to 1/2" per foot crown on remainder

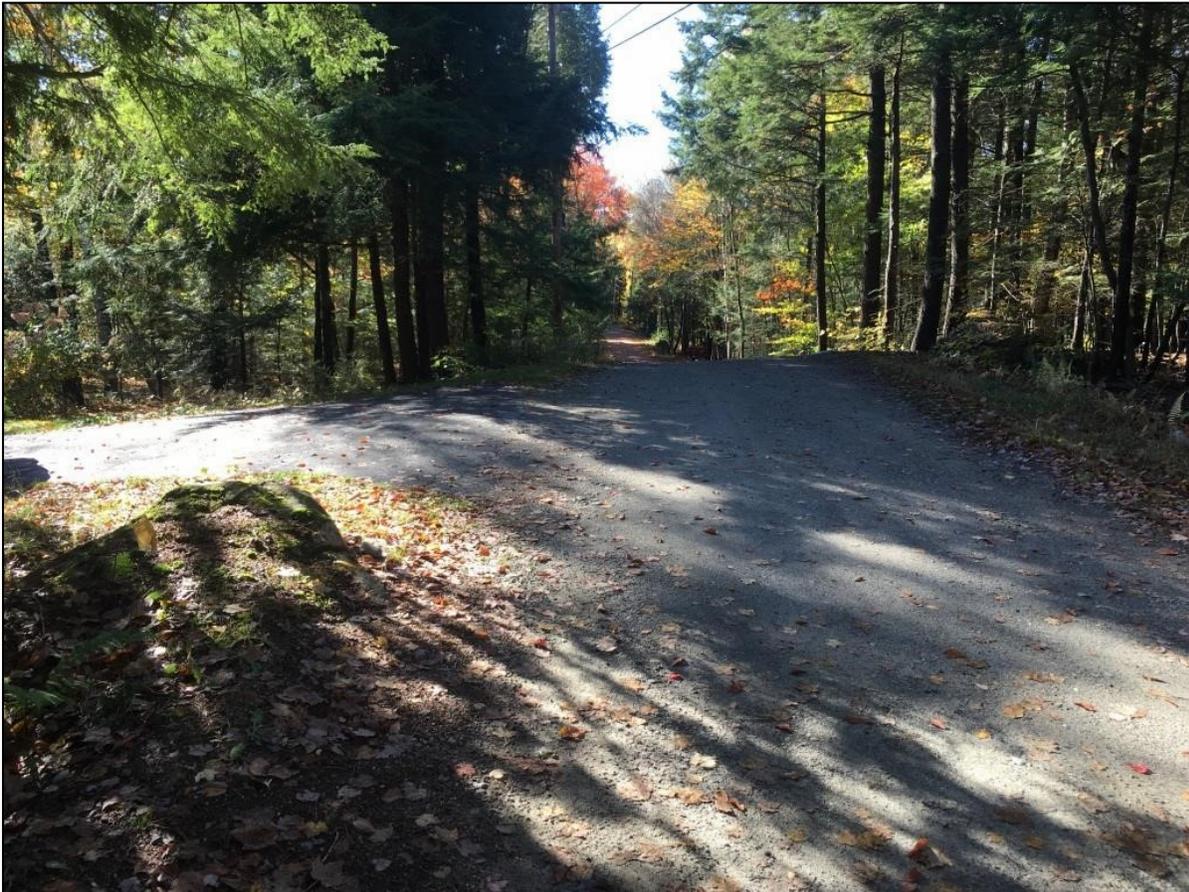
Site # 10: Driveway # 204 – 440' to Driveway # 225 (Cardinali)

Issues: Surface is flat and lacks sufficient surface crown

Previously suggested work has been completed.

Fix: Add 6" (pre-compacted depth) 1" minus crushed gravel or bluestone and compact to 1/2" per foot crown on remainder.

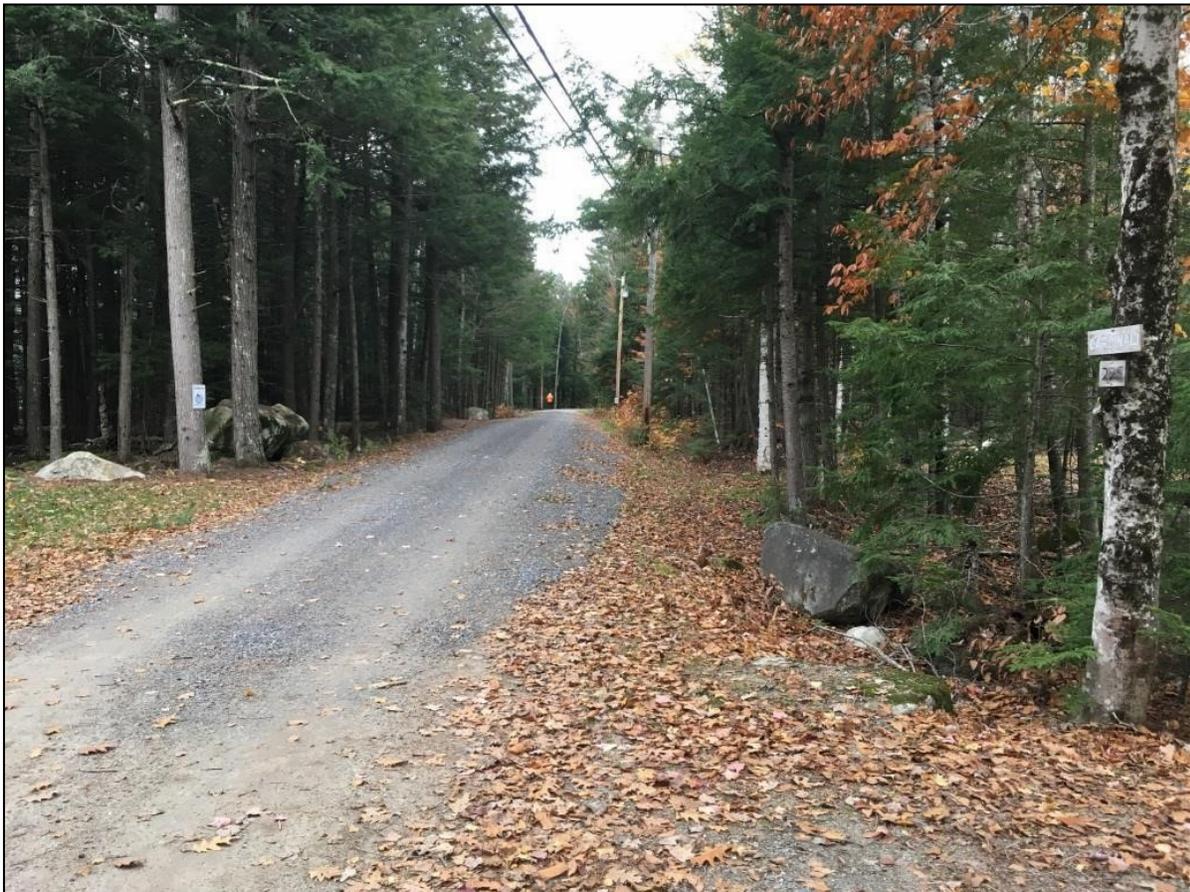
Site # 11: Driveway # 225 – 991' to Driveway # 90

Issues: ~~New bluestone in this section with older bluestone material on hill~~

Fix: Maintain crown at ½” per foot with regular grading. *Site is in good condition, continue to maintain.*

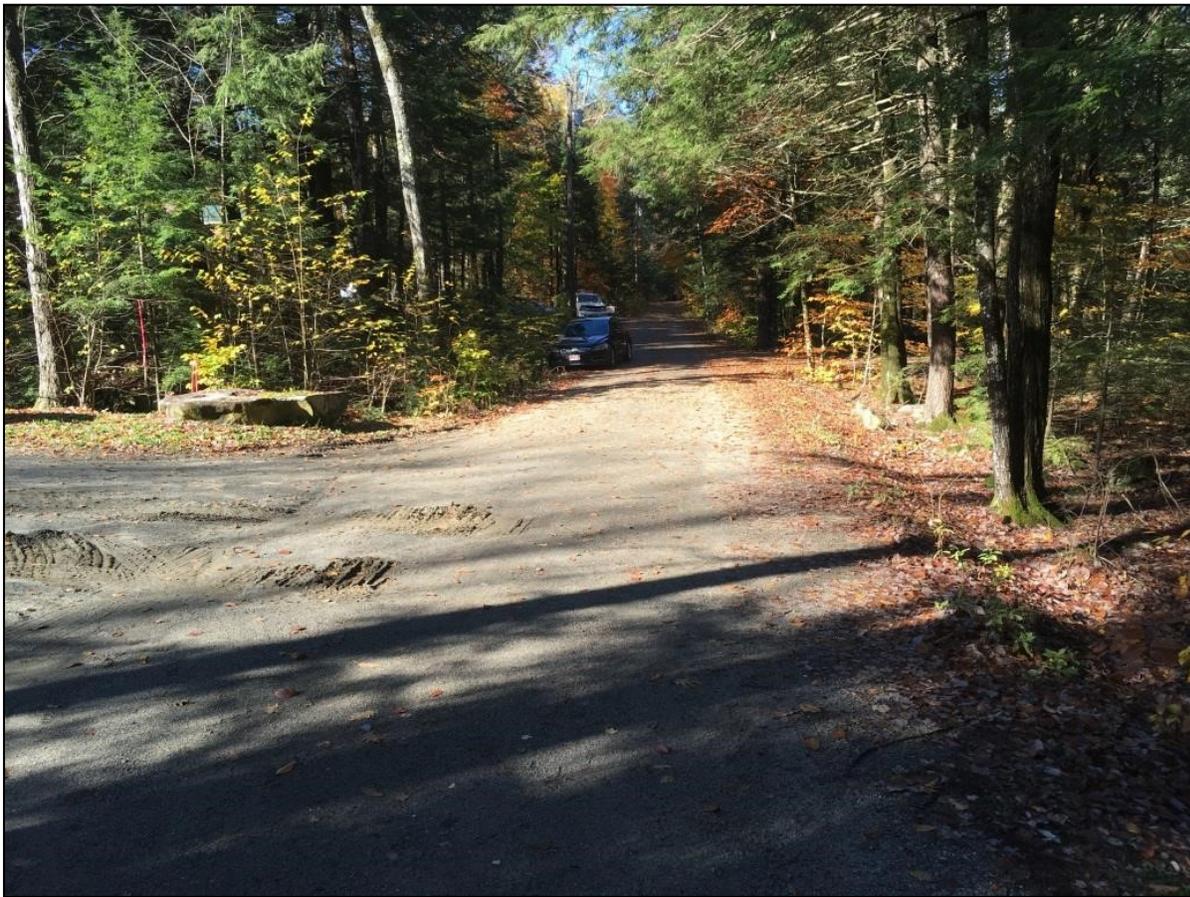
Site # 12: Driveway # 90 – 1123’ to Pole # 8

Issues: Surface is flat and lacks sufficient surface crown, some potholes forming, ledge is present foot crown on remainder
Fix: Add 4” (pre-compacted depth) 1” minus crushed gravel or bluestone and compact to ½” per

Not completed. Add additional surface material to first half of site (Pole #6) and crown. When surface material added to remainder of site, it will be a combination of super-elevated and crowned sections as topography directs.

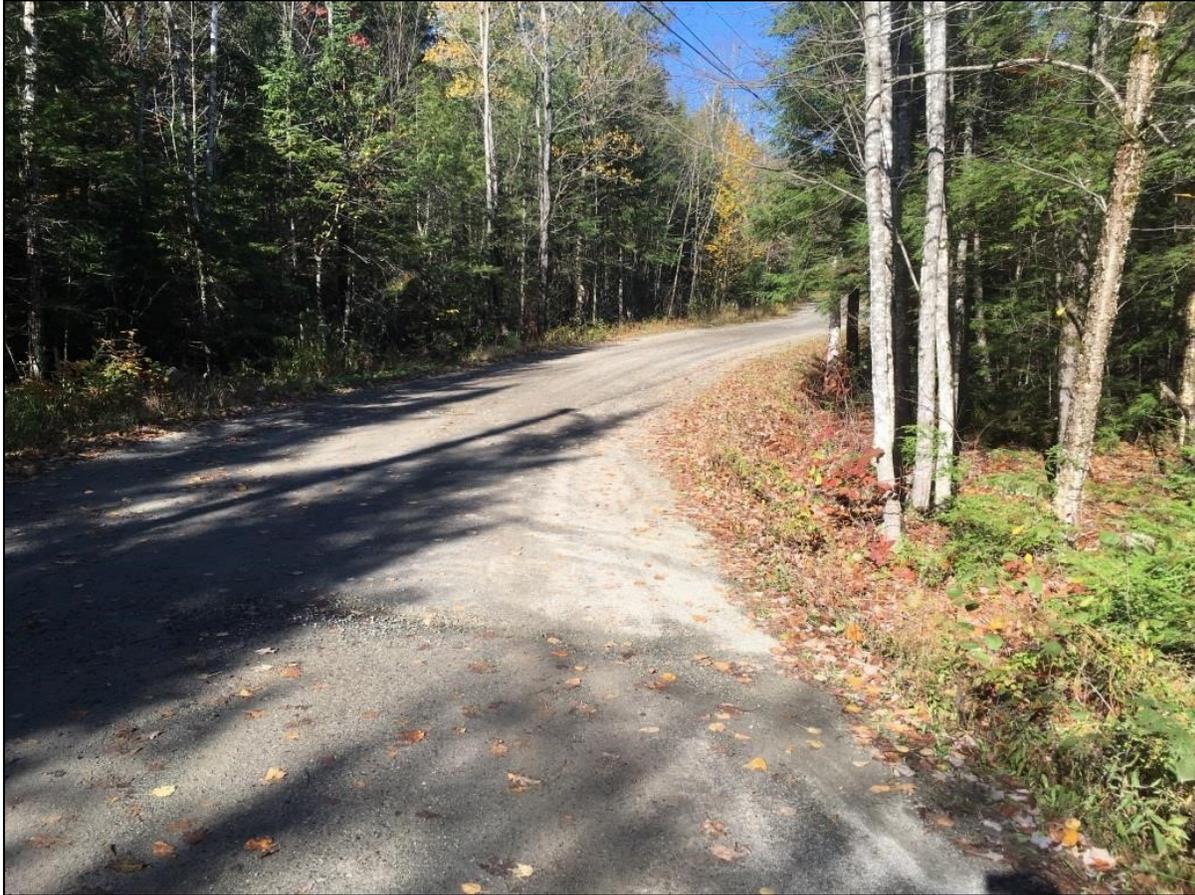
Site # 13: Pole # 8 – 482' to Spruce/Aspen intersection.

Issues: Shoulder berms present preventing water from getting off road surface and shoulders causing potholes. Surface material needs shaping.

Fabric has been installed in a portion of the site and road rebuilt. Maintain crown.

Fix: Shave shoulder berms, cut potholes and reshape crown so water drains off surface and shoulders.

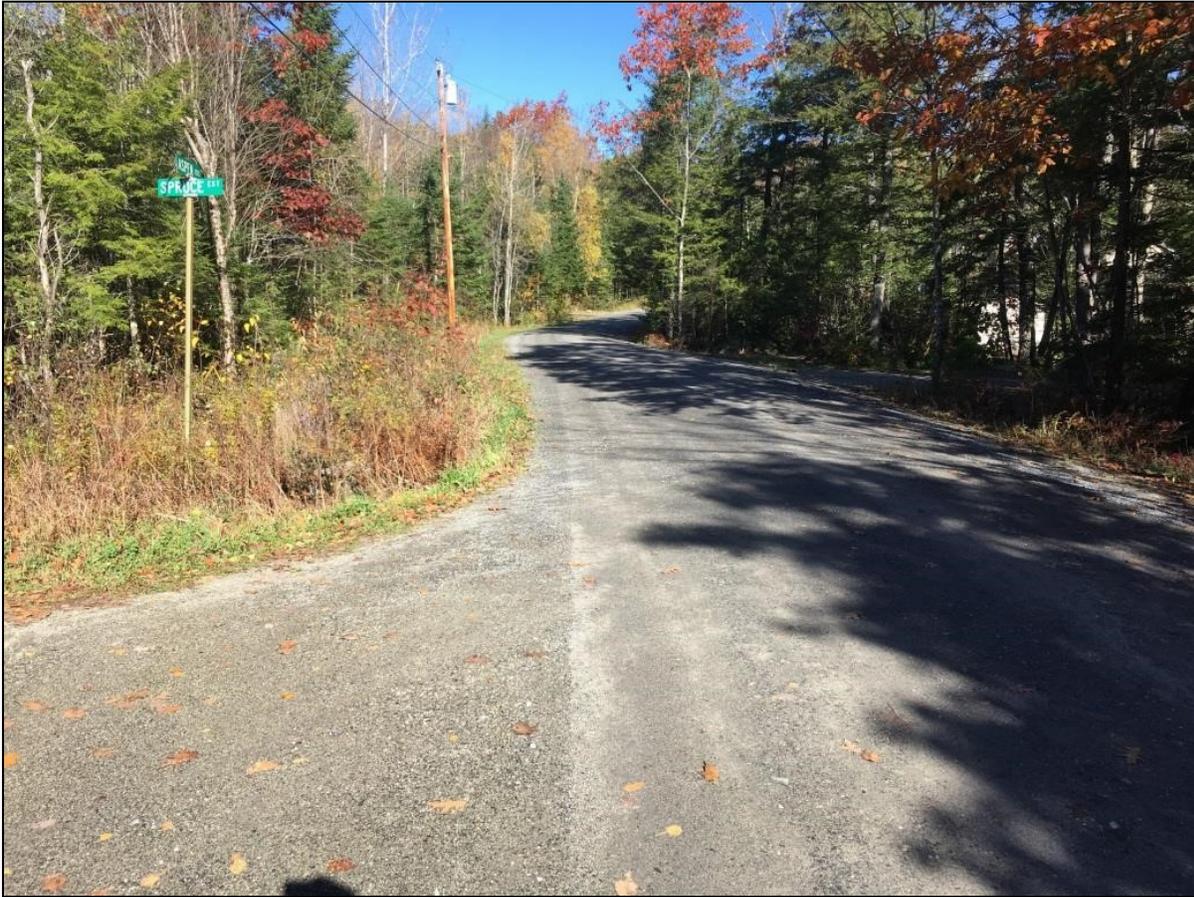
Site # 14: Beginning of Aspen – 555' to intersection with Wildewood

Issues: Site is in good condition with sufficient bluestone and crown

Fix: Maintain crown at ½" per foot with regular grading. *Site*

is in good condition, continue to maintain crown.

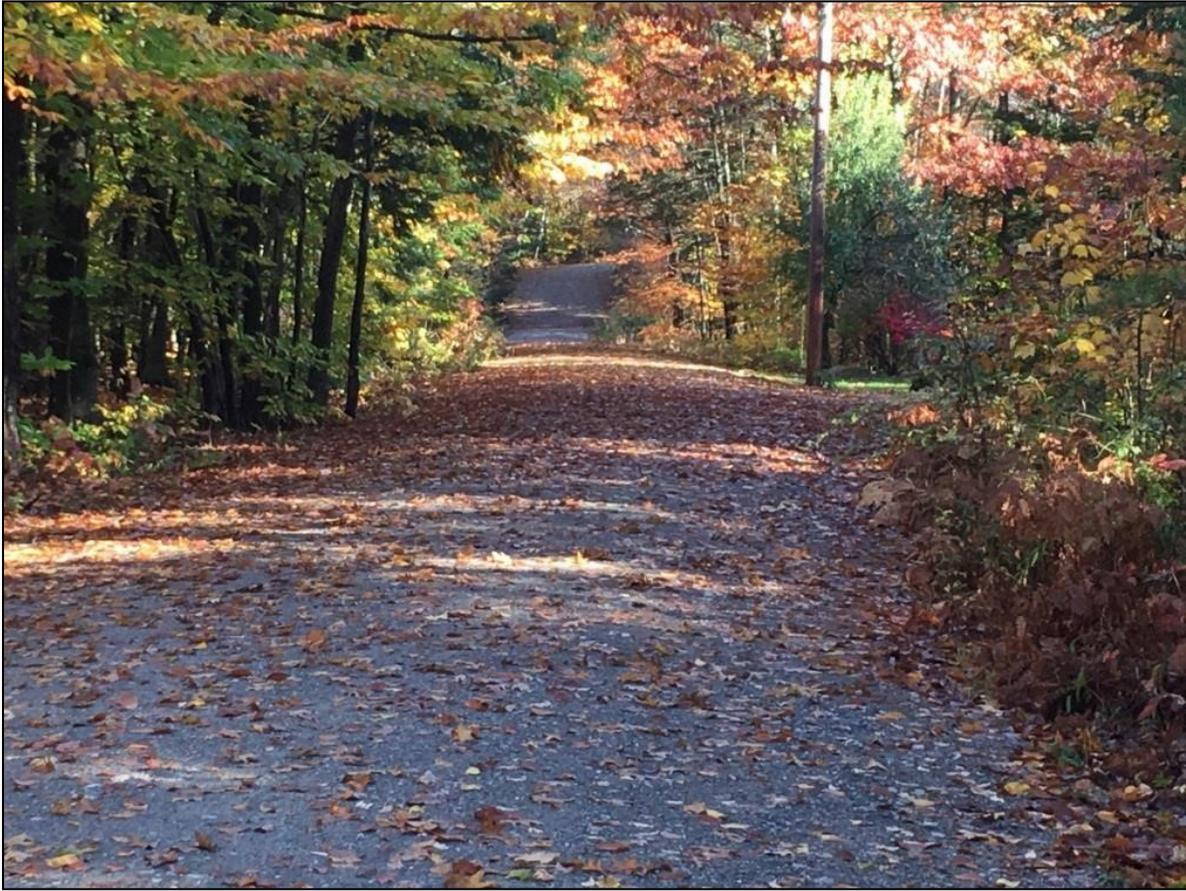
Site # 1: Beginning of Birch -629' to end of new gravel section

Issues: Site is in good condition with sufficient 1" minus gravel and crown. Existing 18" metal culvert at 424' has failed.

Culvert has been replaced and site remains in good condition.

Fix: Replace existing culvert with 18" HDPE culvert and maintain crown at ½" per foot with regular grading. **Site # 2**

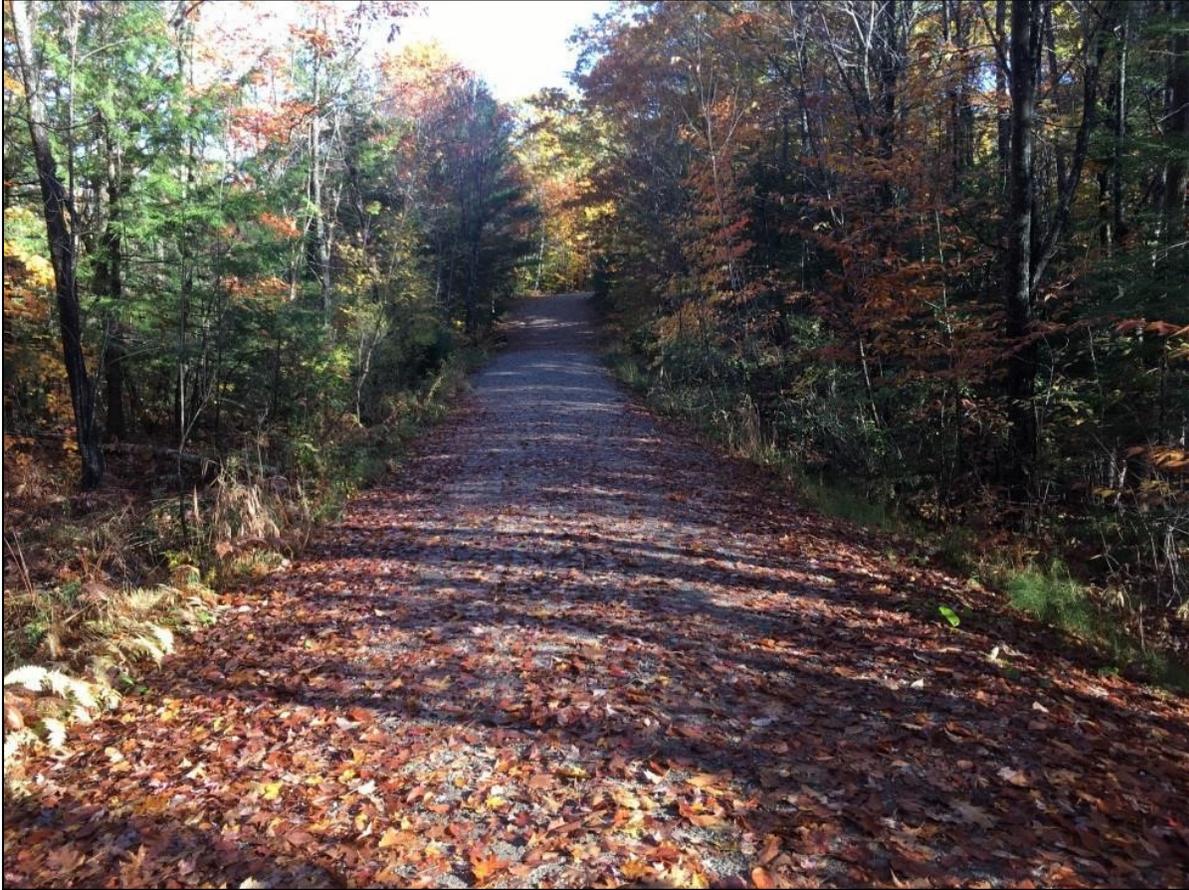
Site # 2: Bottom of hill – end of Site # 1 – 900’ to Pole # 3.1 at end of road.

Issues: Lack of surface crown, rutting, shoulder berms

Bluestone has been installed on hill, but shoulders are eroding and surface needs shaping.

Fix: On hill - Add 12” (pre-compacted depth) 1” minus crushed gravel or bluestone and compact to ½” per foot crown. Install 6” (pre-compacted depth) 1” minus crushed gravel or bluestone and compact to ½” per foot crown on remainder of road.

Increase depth of north side ditch above curve (approx. 50’) to driveway culvert at new house (#38). Remove large rock at outlet end of new driveway culvert. Add additional bluestone around curve and increase crown to ½” per foot.

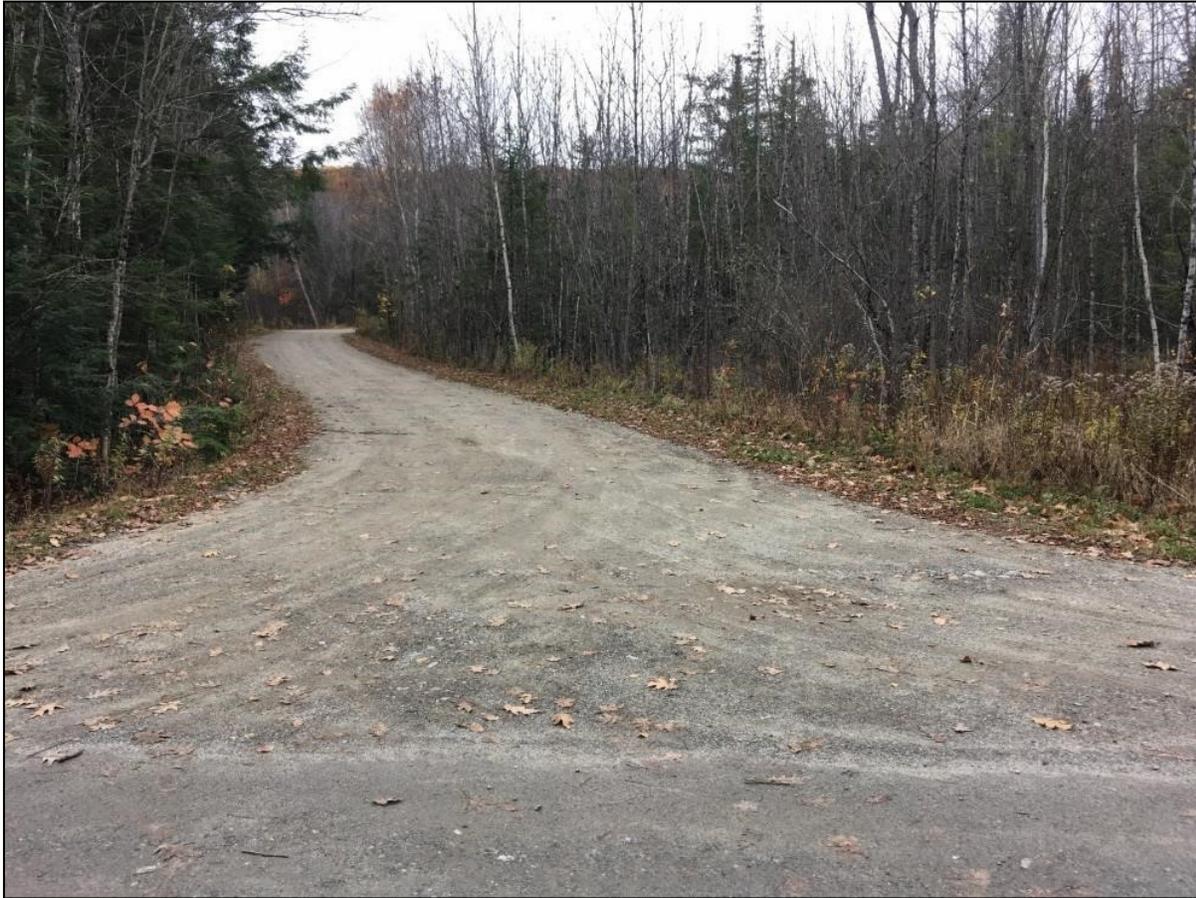
Spruce Estates

Issues: Lack of surface crown, rutting, on hills, shoulder berms

Upper portion completed. Lower portion washed out from storm. 6" minus material was installed to rebuild base. New surface gravel or bluestone needed over area where stone was installed beyond driveway #21. Crown new material to 1/2" per foot. Make sure ditching and culvert that plugged during storm is kept clean and free of debris.

Fix: Shave shoulder berms and install 6" (pre-compacted depth) 1" minus crushed gravel or bluestone and compact to 1/2" per foot crown.

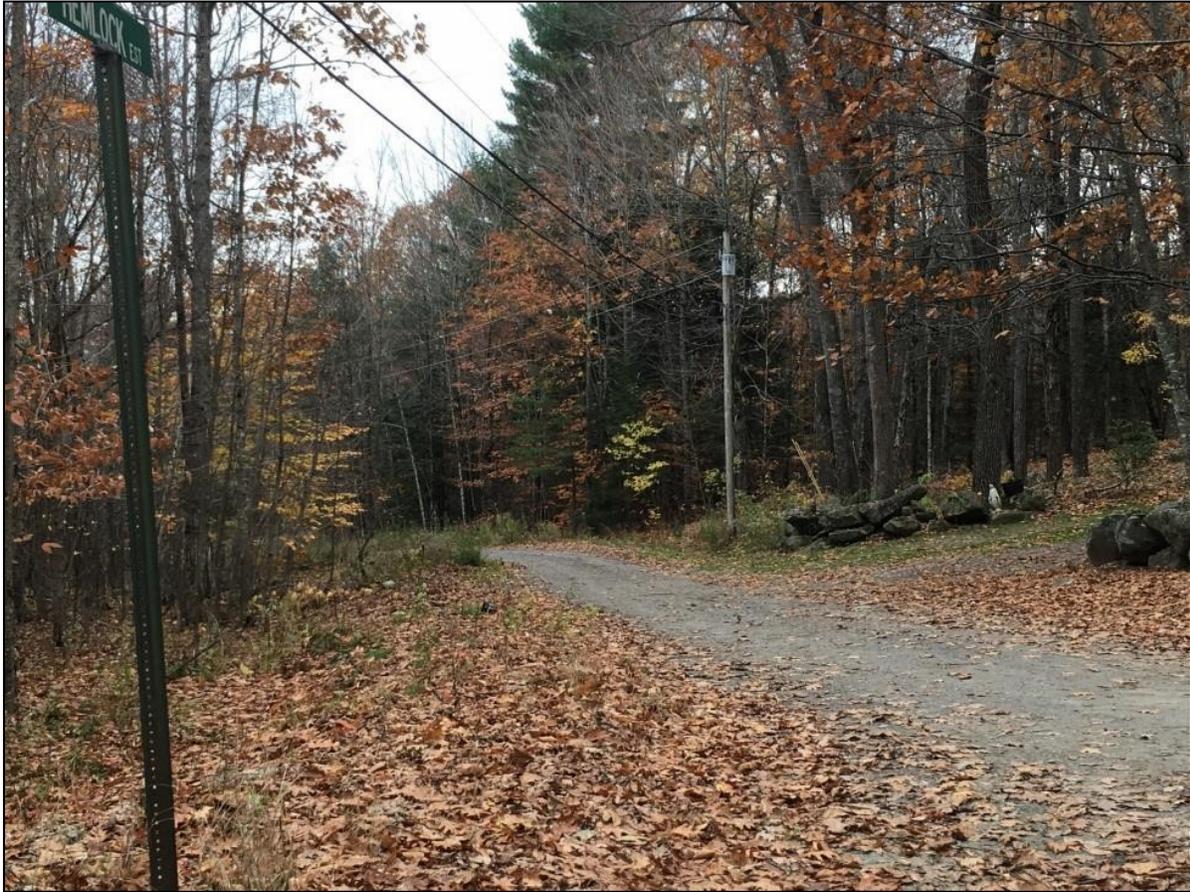
Hemlock Estates

Issues: Lack of surface crown, rutting, significant shoulder berms. *Two new houses built on Hemlock since original plan in 2017.*

Not completed, needs surface material and crowning to Pole #3. Area beyond Pole #3 washed out in December 2023 storm and had 6" minus material added to rebuild base. This section needs surface gravel or bluestone so it can be crowned to 1/2" per foot.

Fix: Shave/remove shoulder berms and install 6" (pre-compacted depth) 1" minus crushed gravel or bluestone and compact to 1/2" per foot crown.
