Gravel Road Design & Management Plan

*Wildewood Estates Road District Rome,
Maine*

Maine Environmental Solutions, LLC

Updated July 2024

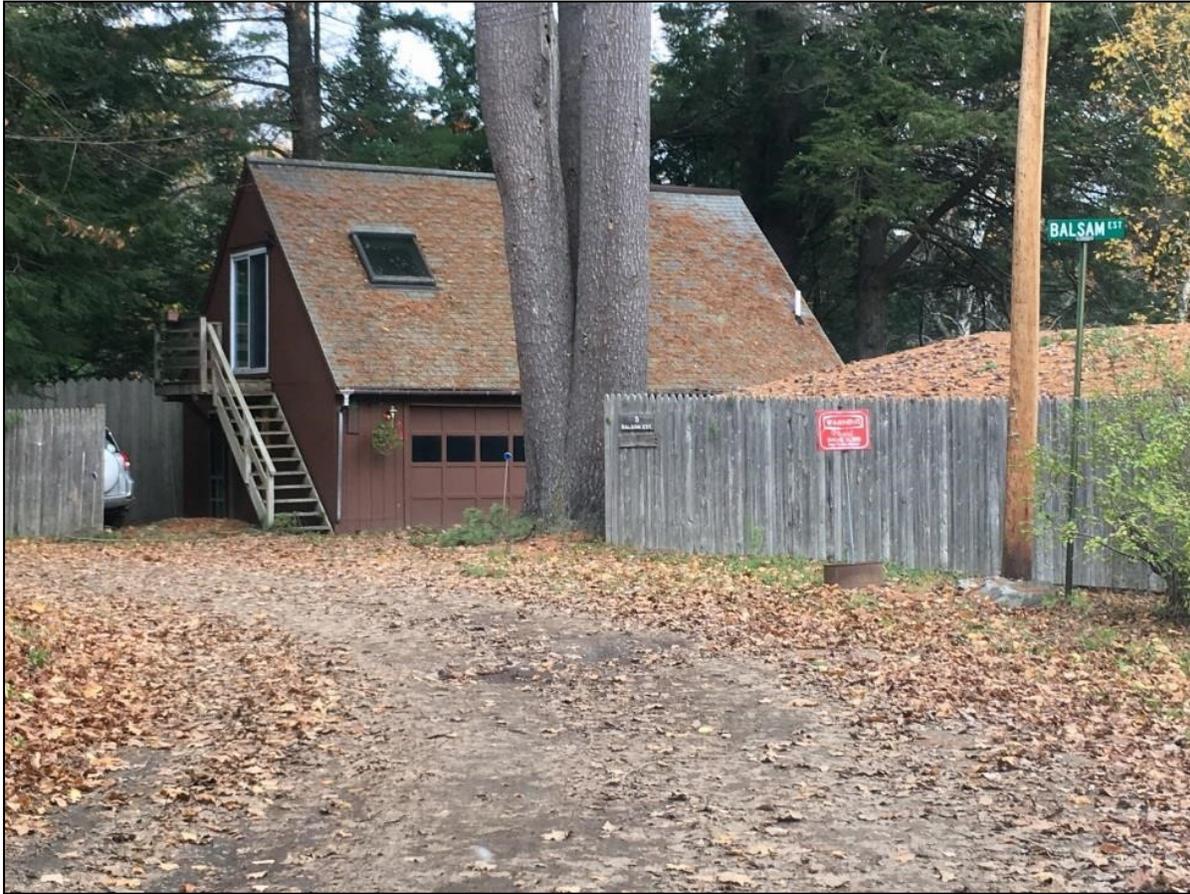
Balsam Estates

Issues: Lack of surface crown in beginning. Remainder of road has had recent work done and is in good condition with new culverts and crown.

Previously suggested work has been completed as part of a Maine DEP 319 grant. Two 24" culverts and a single 12" have been installed before the beach parking area. Bluestone has been installed on surface and crowned to $\frac{1}{2}$ " per foot.

Fix: Install 6" (pre-compacted depth) 1" minus crushed gravel or bluestone and compact to $\frac{1}{2}$ " per foot crown along beginning section. Maintain remainder with $\frac{1}{2}$ per foot crown.

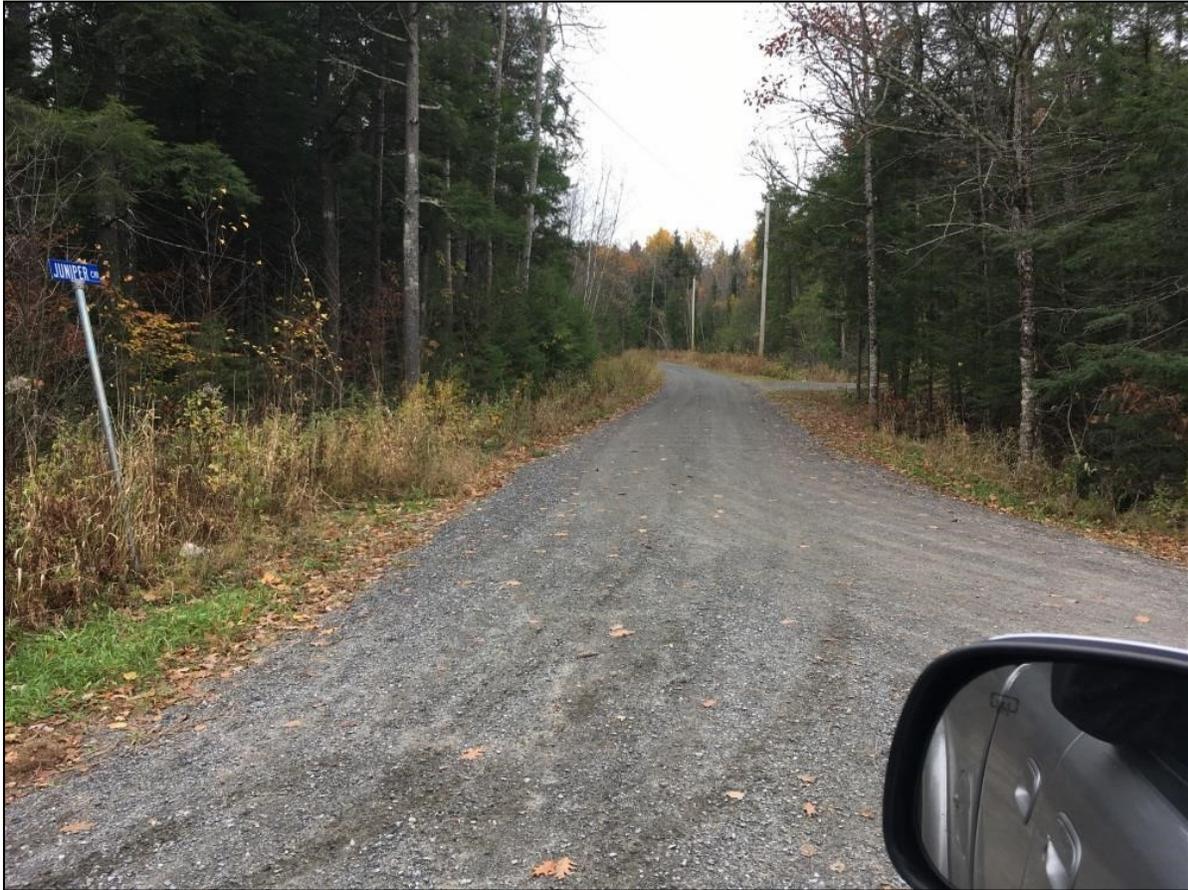
Juniper Circle

Issues: Beginning of south side of Juniper – new bluestone added, Remaining .1 mile – lack of surface crown *and rutting*.

Fix: Maintain crown on new section. Install 3-4" (pre-compacted depth) 1" minus crushed gravel or bluestone and compact to $\frac{1}{2}$ " per foot crown on remaining portion of road. *Rock sandwich has been installed between driveway #63 & 75. Add surface material as needed and crown to $\frac{1}{2}$ " per foot.*

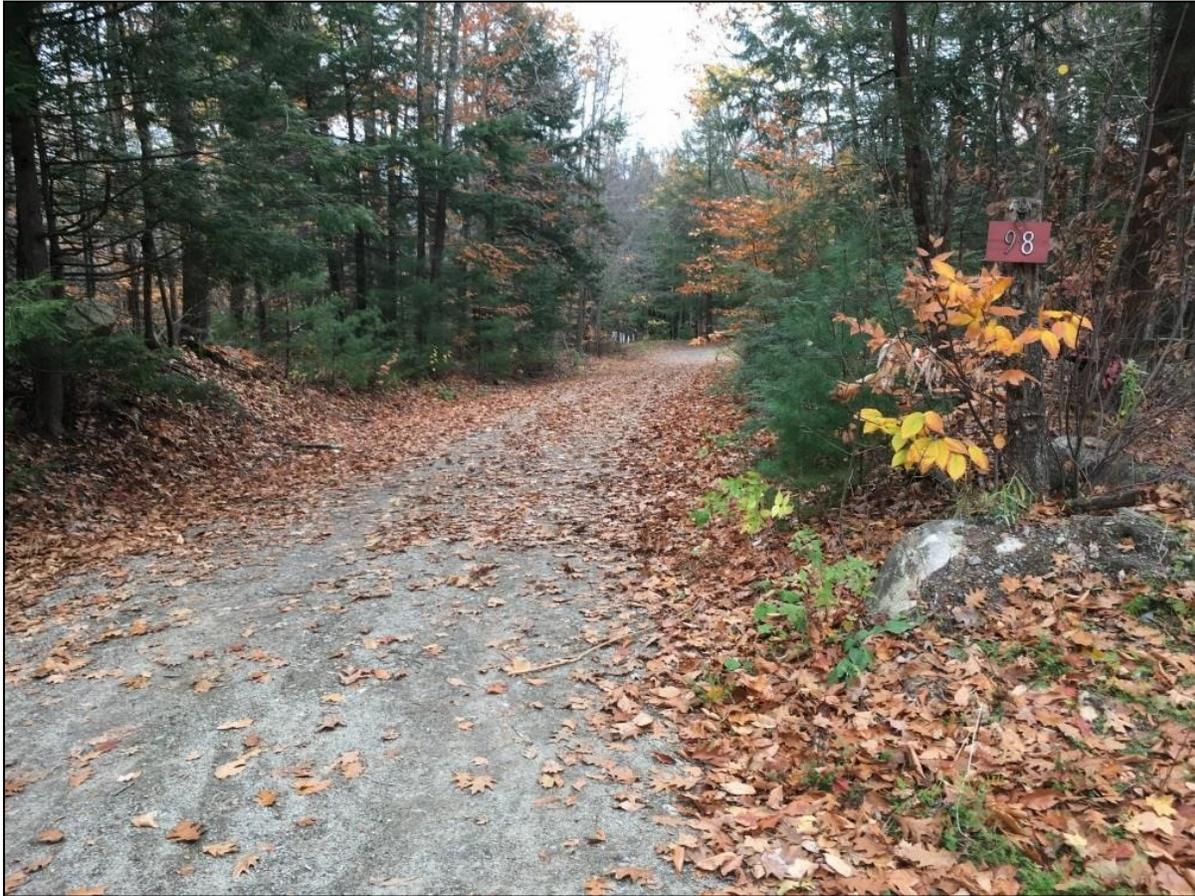
Hill at Driveway # 98

Issues: Road is sloped to existing ditch on left (super-elevated)
Fix: Maintain super-elevation to left adding material as needed.

Continue surface shaping as needed so water drains to ditch.

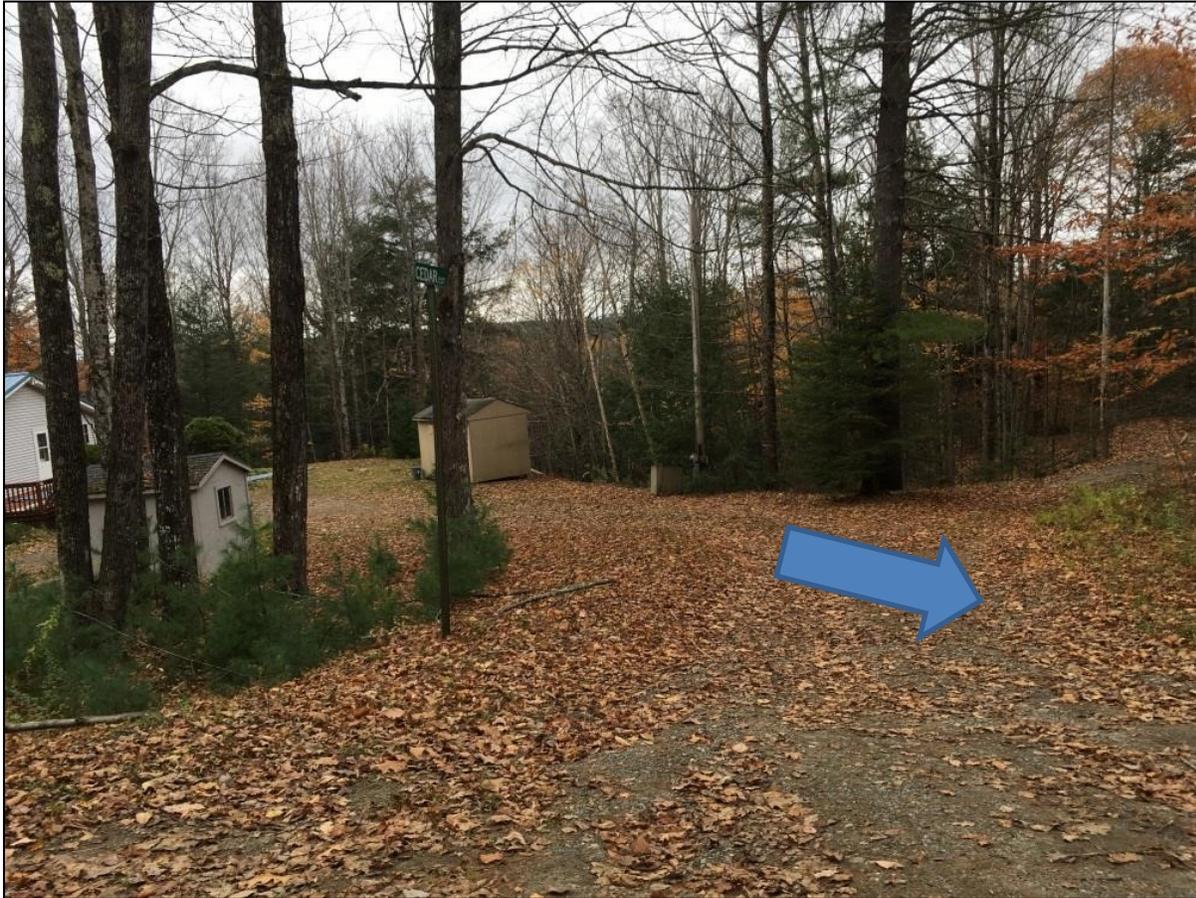
Cedar Estates

Issues: Road is acting as the ditch and water not getting off surface

Previously suggested work has been completed and drainage has improved.

Fix: Super-elevate road to right side, for 75', so water can shed away from driving surface. Raise road base 1' with 4" minus gravel and add 6" (pre-compacted depth) of 1" minus crushed gravel or bluestone to the surface.

If runoff goes down driveway on right, install gravel water bar to move water off road surface.

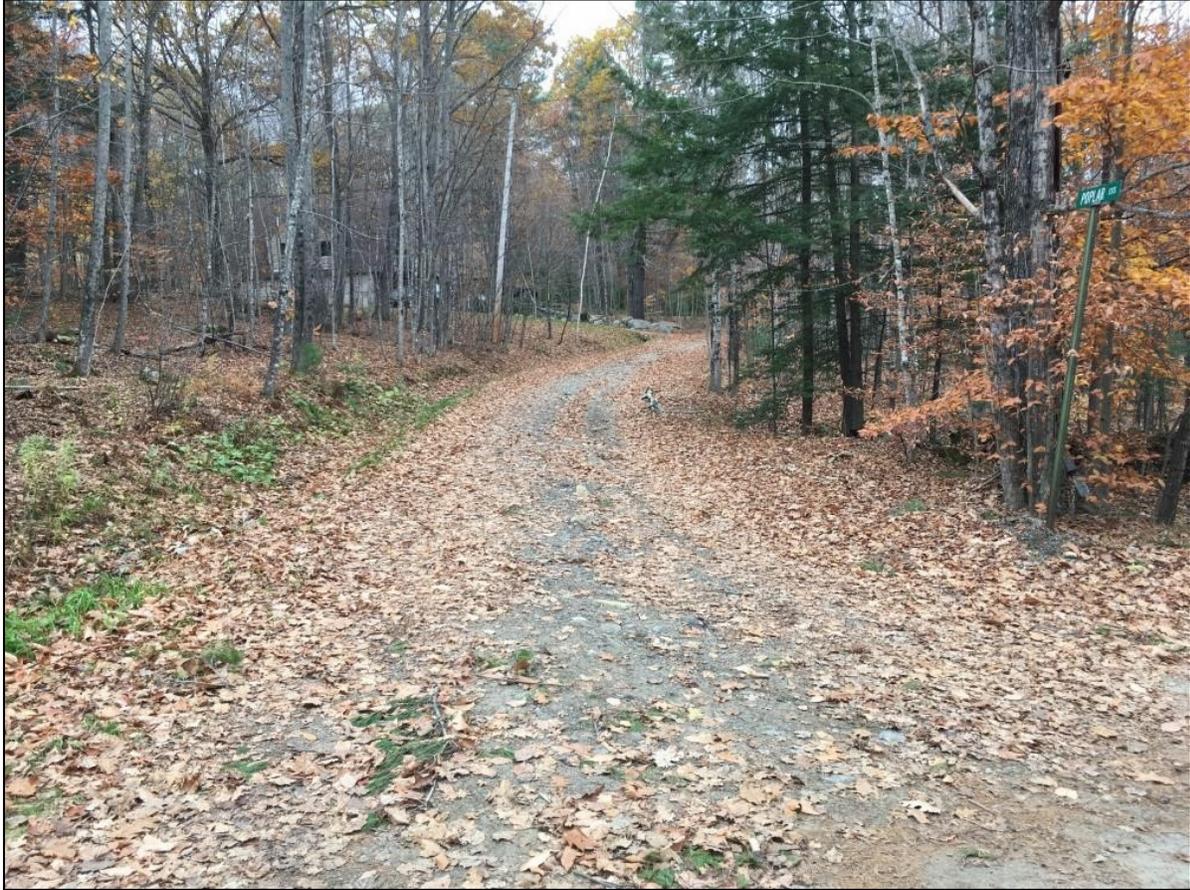
Poplar Estates

Issues: Lack of surface crown, water not reaching ditching, shoulder berms

Fix: If construction of a new house on the lot at the end is planned, wait until large vehicles are finished to improve road.

Shave shoulder berms and install 8" (pre-compacted depth) of 1" minus crushed gravel or bluestone and compact to $\frac{1}{2}$ " per foot crown on sections that have existing ditching. Areas without ditching on left (*west*) should be super-elevated toward woods on right (*east*).
